**Contract No. HY/2009/15**

**Central – Wan Chai Bypass – Tunnel (Causeway Bay Typhoon Shelter Section)**

**Environmental Permit No.: FEP-06/364/2009/A – Landscape Plan (Revision 3)**

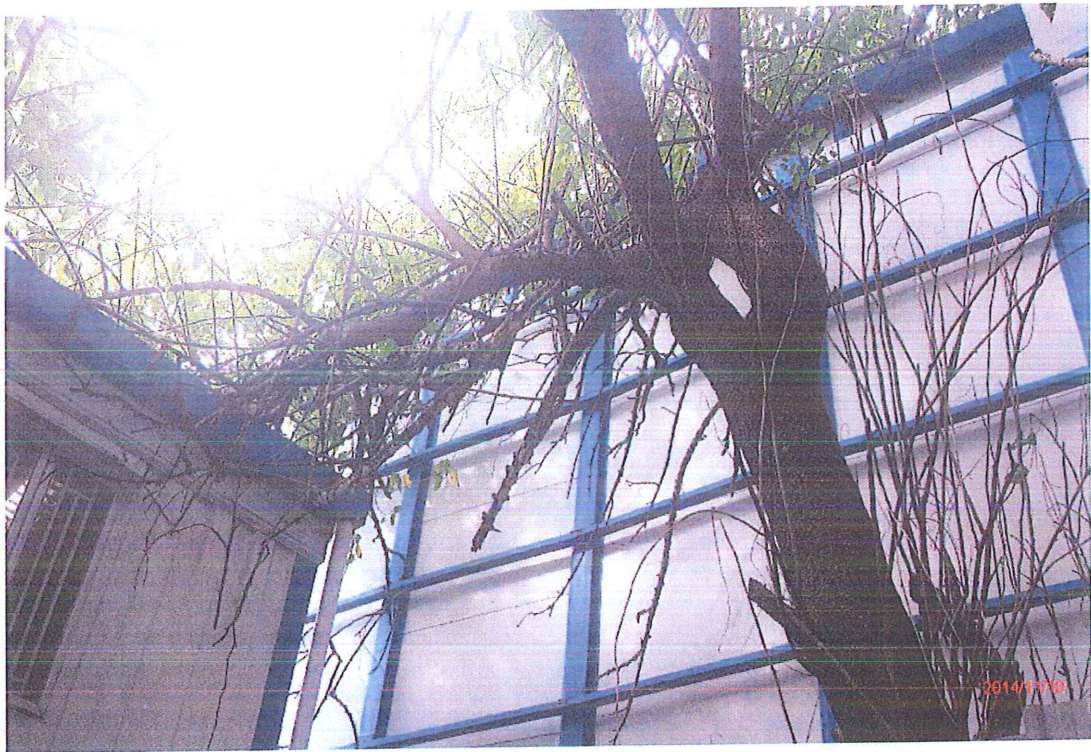
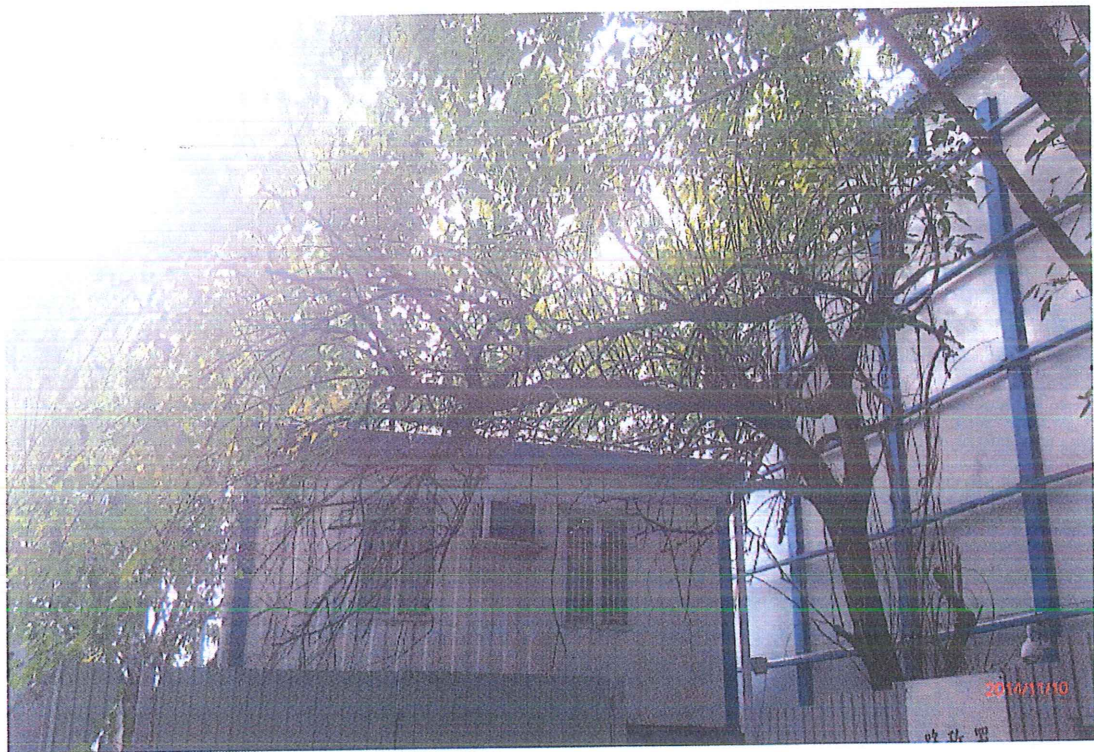
T1921 :  
Sign of  
decay –  
Minor  
(Tree  
condition  
under close  
observation)

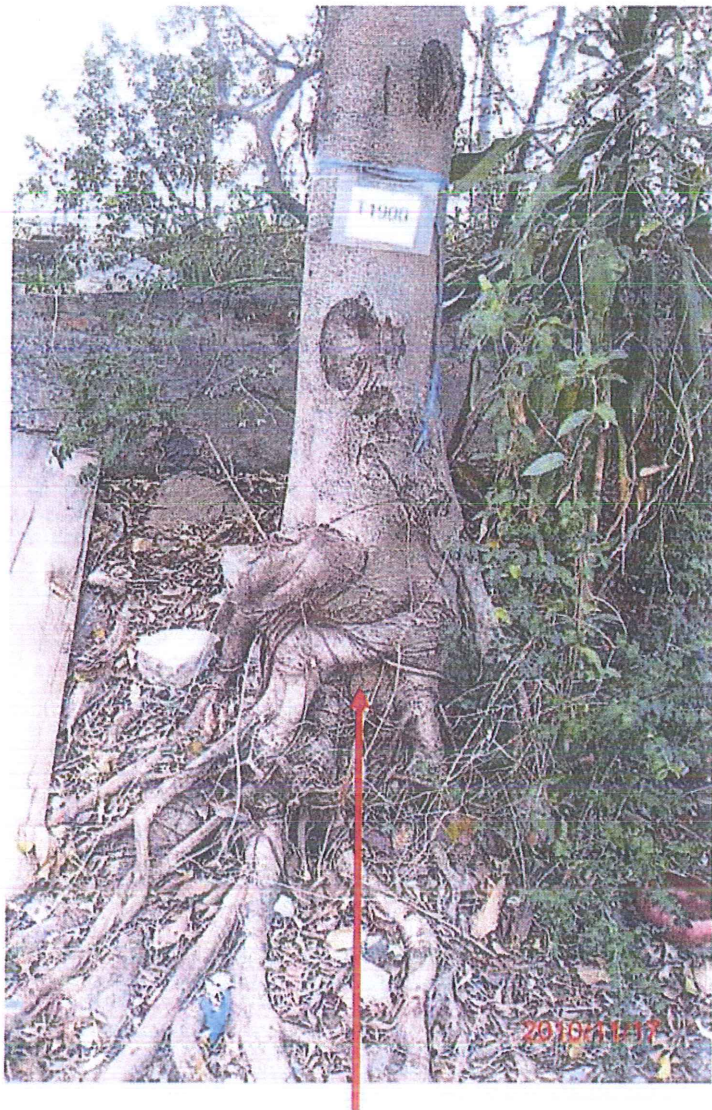
(a) Tree no. T1900 - *Ficus virens* 大葉榕, 黃葛樹

Root system distorted due to confined growing space between rock. Preparation of rootball is unfeasible for survival of transplanting

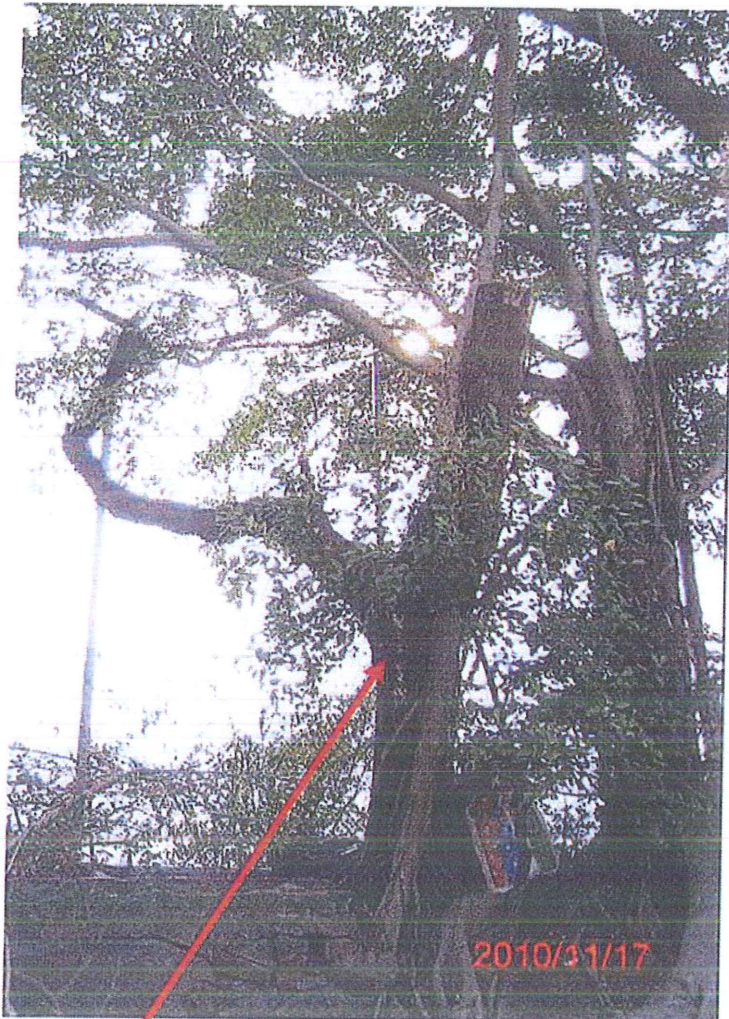
(b) Tree no. T1901 - *Ficus benjamina* 垂葉榕

Dead tree

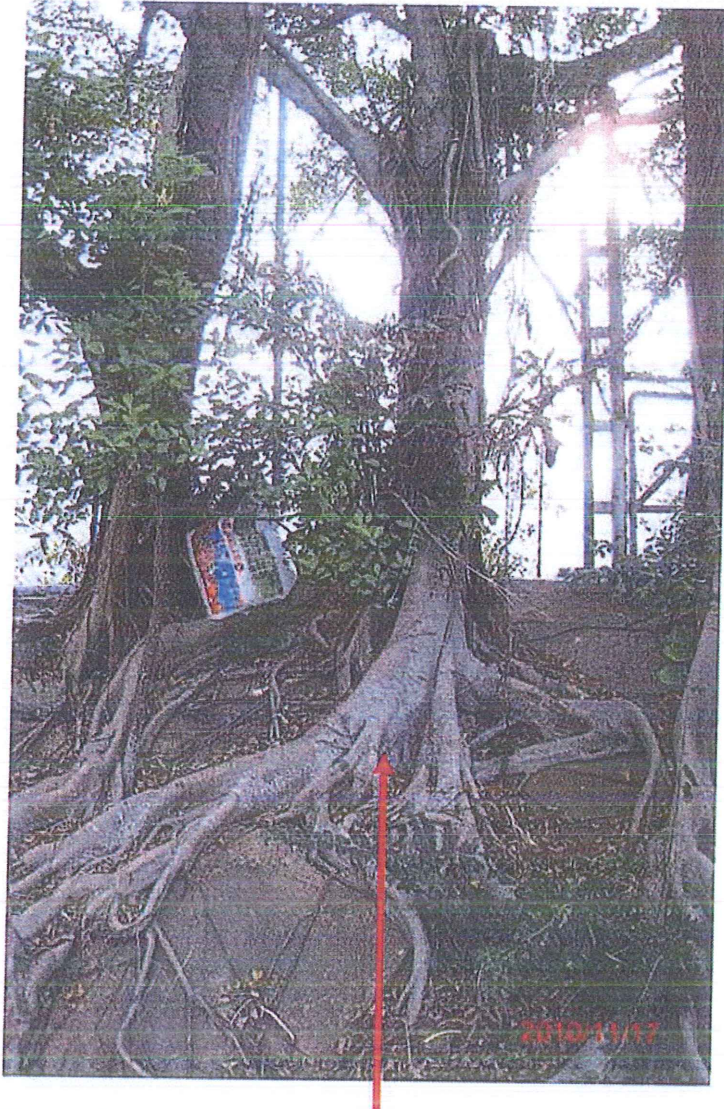
T1902

Rootball locates on large boulder at slope and clashing with adjacent roots of trees. Preparation would drastically affect rootball and structural stability

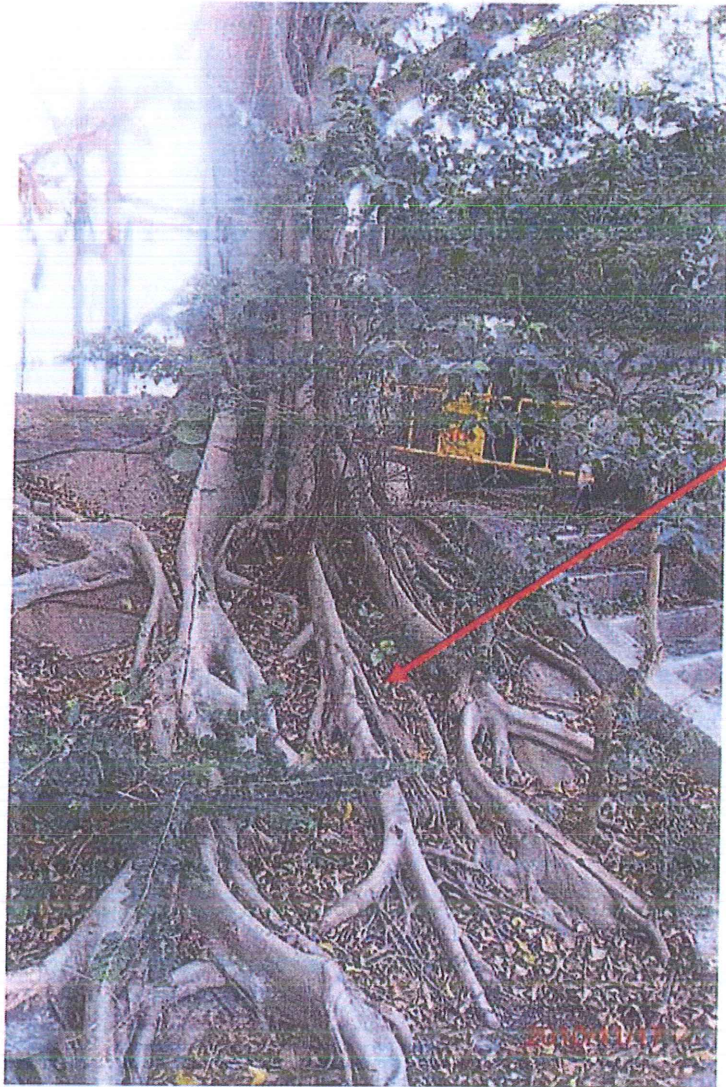
(d) Tree no. T1903 - *Ficus benjamina* 垂葉榕

Growing on slope area

Root system distorted due to confined growing space between rock. Preparation of rootball is unfeasible for survival of transplanting.

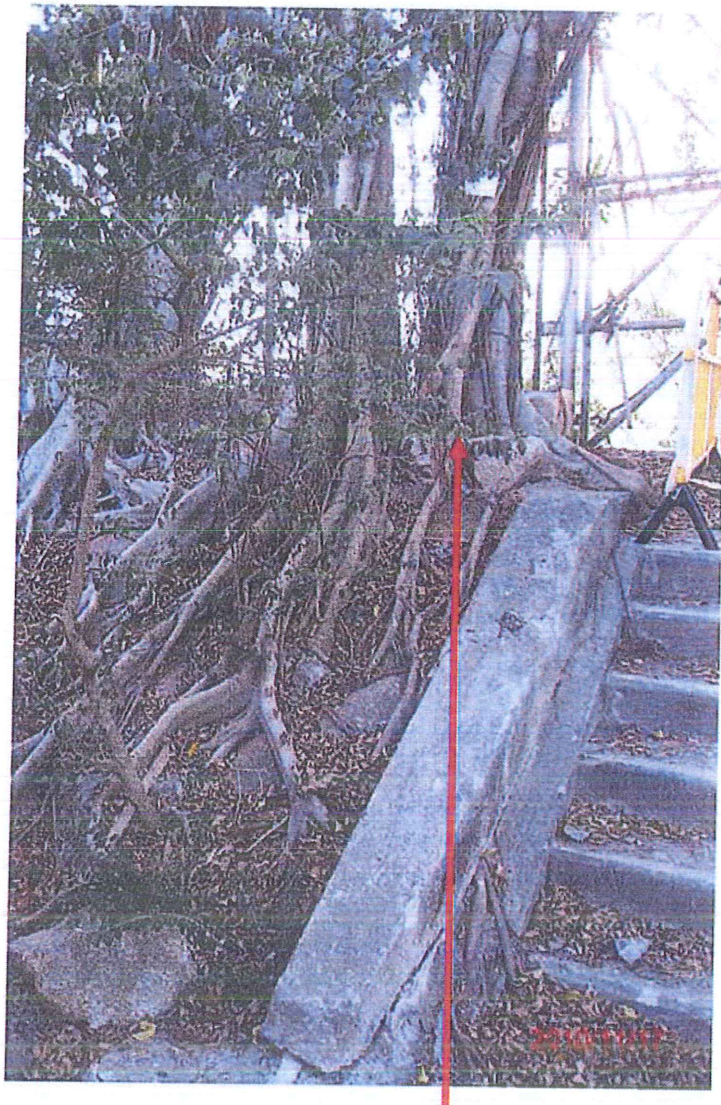
(e) Tree no. T1904 - *Ficus benjamina* 垂葉榕

Rootball locates on large boulder at slope and clashes with adjacent roots of trees. Preparation would drastically affect rootball and structural stability

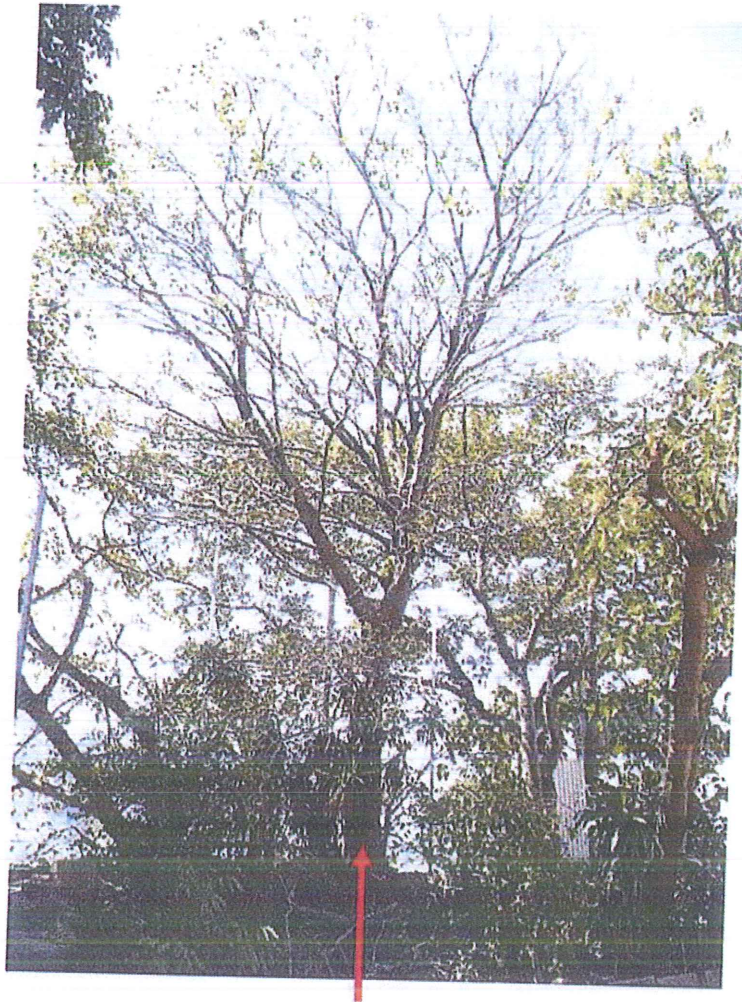
(g) Tree no. T1906 - *Celtis sinensis* 朴樹

Tree locates on uneven levels

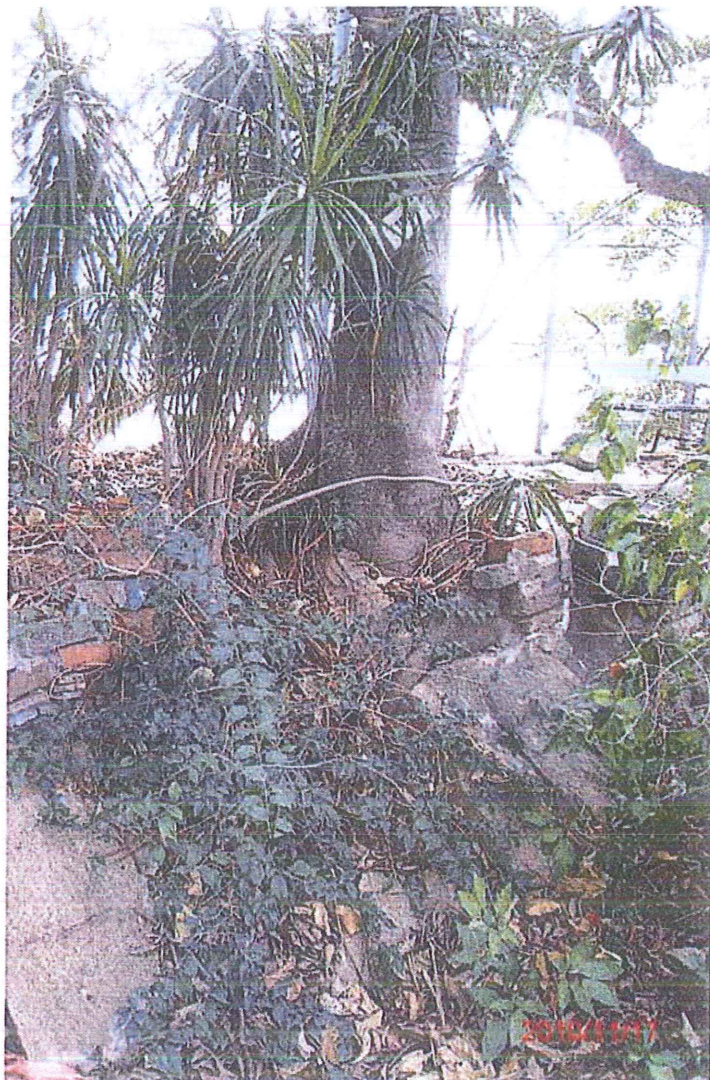
Root system distorted due to confined growing space between rock. Preparation of rootball is unfeasible for survival of transplanting

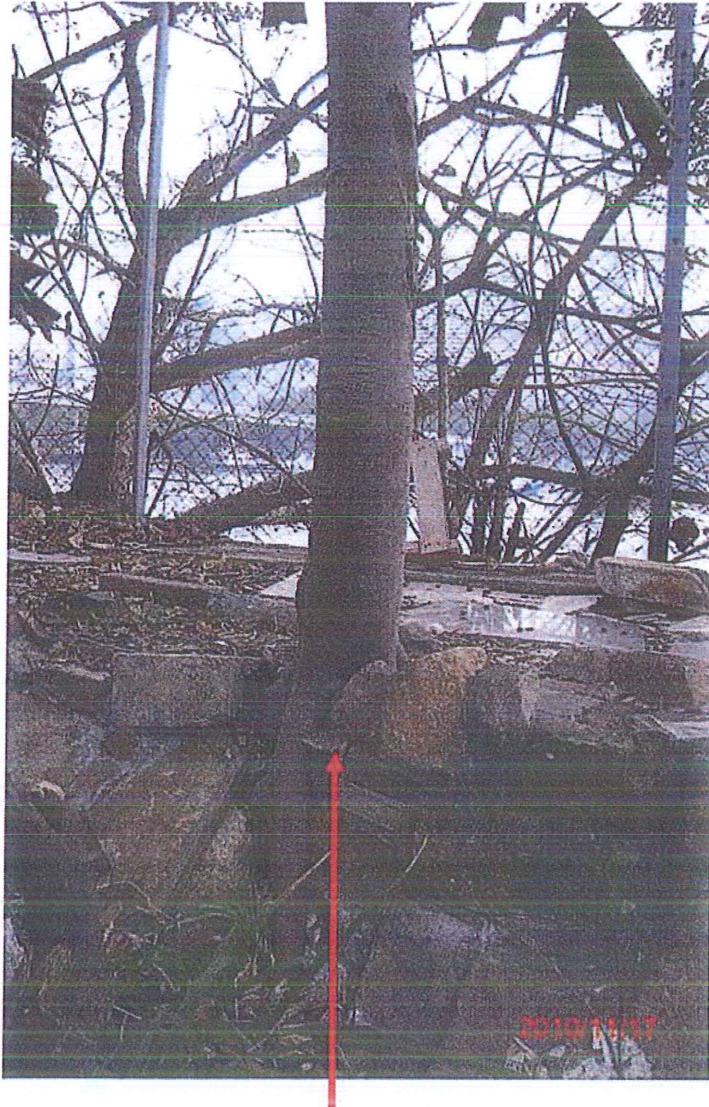
(h) Tree no. T1907 - *Ficus variegata* 青果榕

Root system distorted due to rock.  
Limited root system coverage for stability.

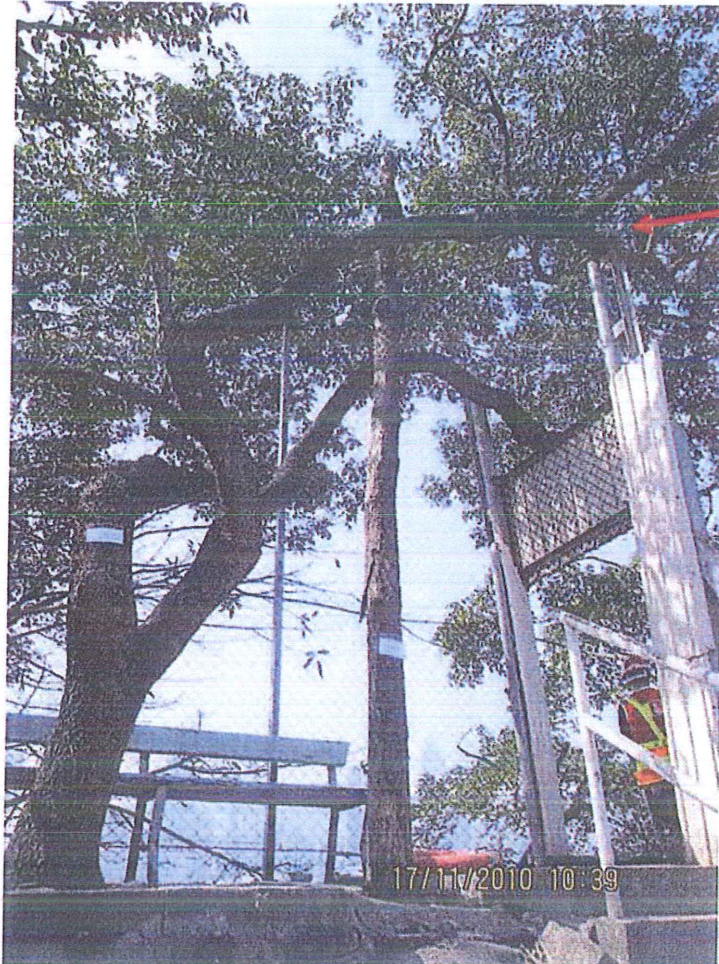
(i) Tree no. T1908 - Albizia lebbbeck 大葉合歡

Tree is leaning using  
adjacent steel as  
support for main  
canopy

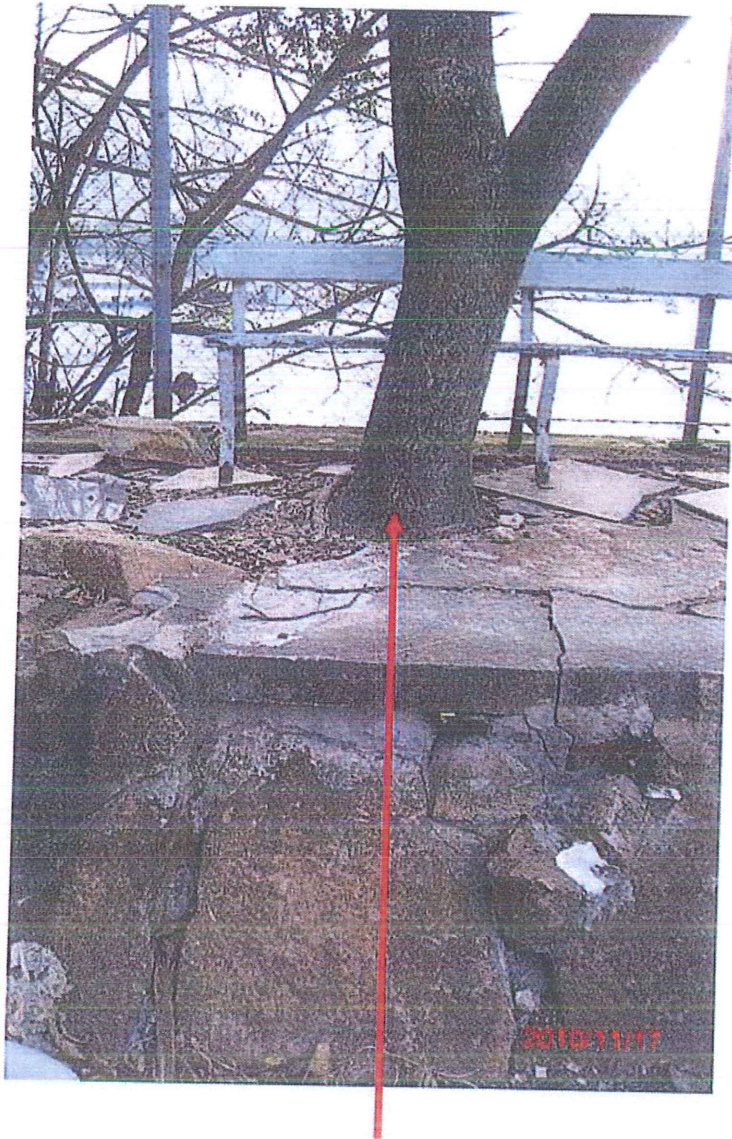
Rootball locates in rocks.  
Limited area due to rock and adjacent slope profile.  
Root system distorted within ground profile.

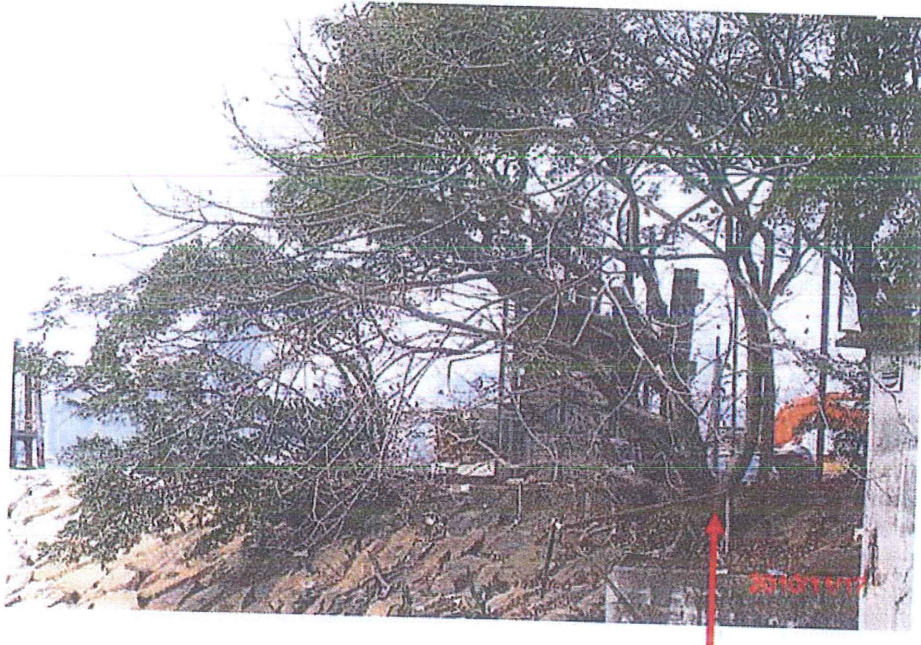
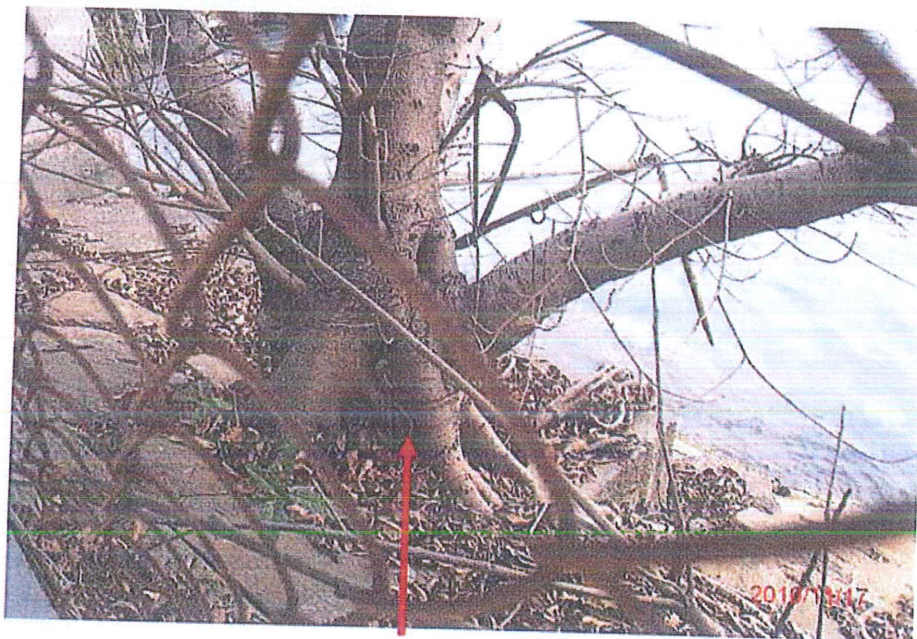
(k) Tree no. T1910 - *Ficus virens* 大葉榕, 黃葛樹

Distorted rootball grows in 45 degree rock slope

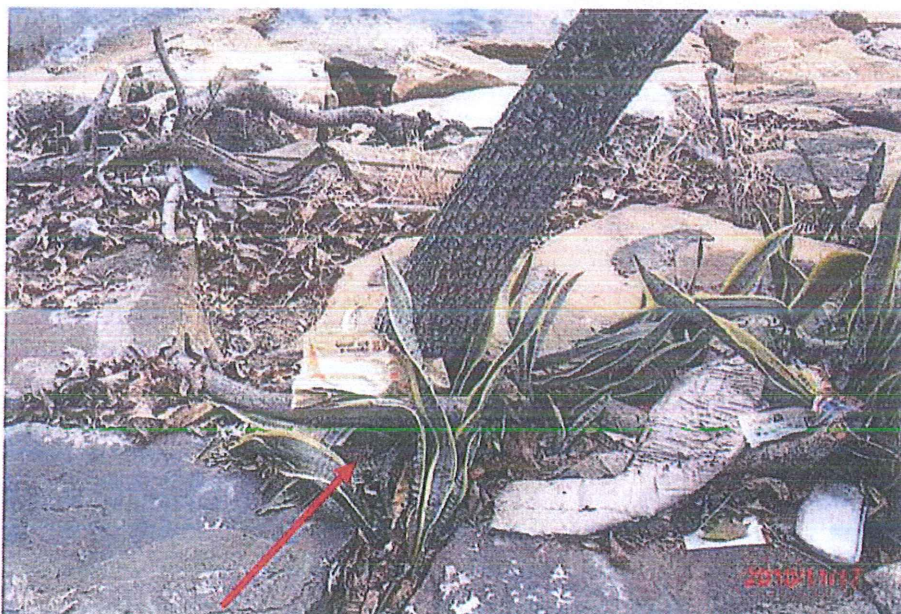
Leaning severely within existing rock slope

Rootball distorted due to growth in rock slope gradient

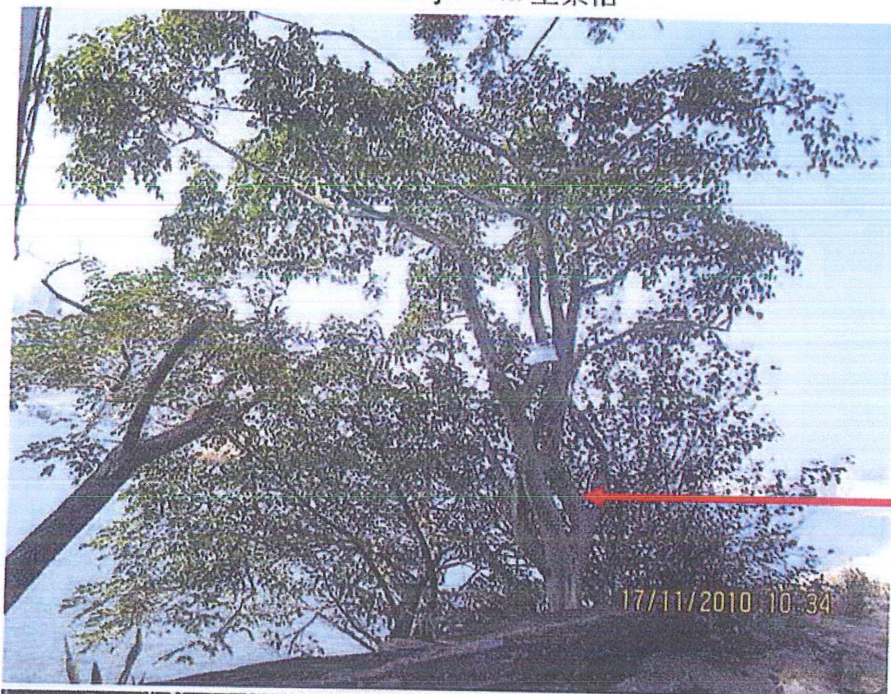
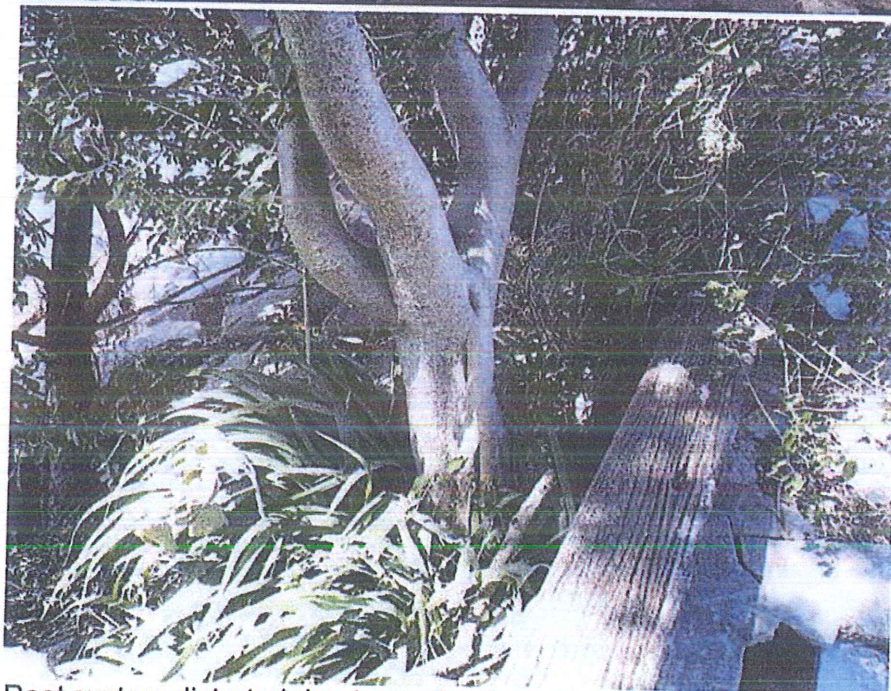
(m) Tree no. T1912 - *Ficus benjamina* 垂葉榕

Root system distorted due to confined growing space between rocks.  
Preparation of rootball is unfeasible for survival of transplanting.

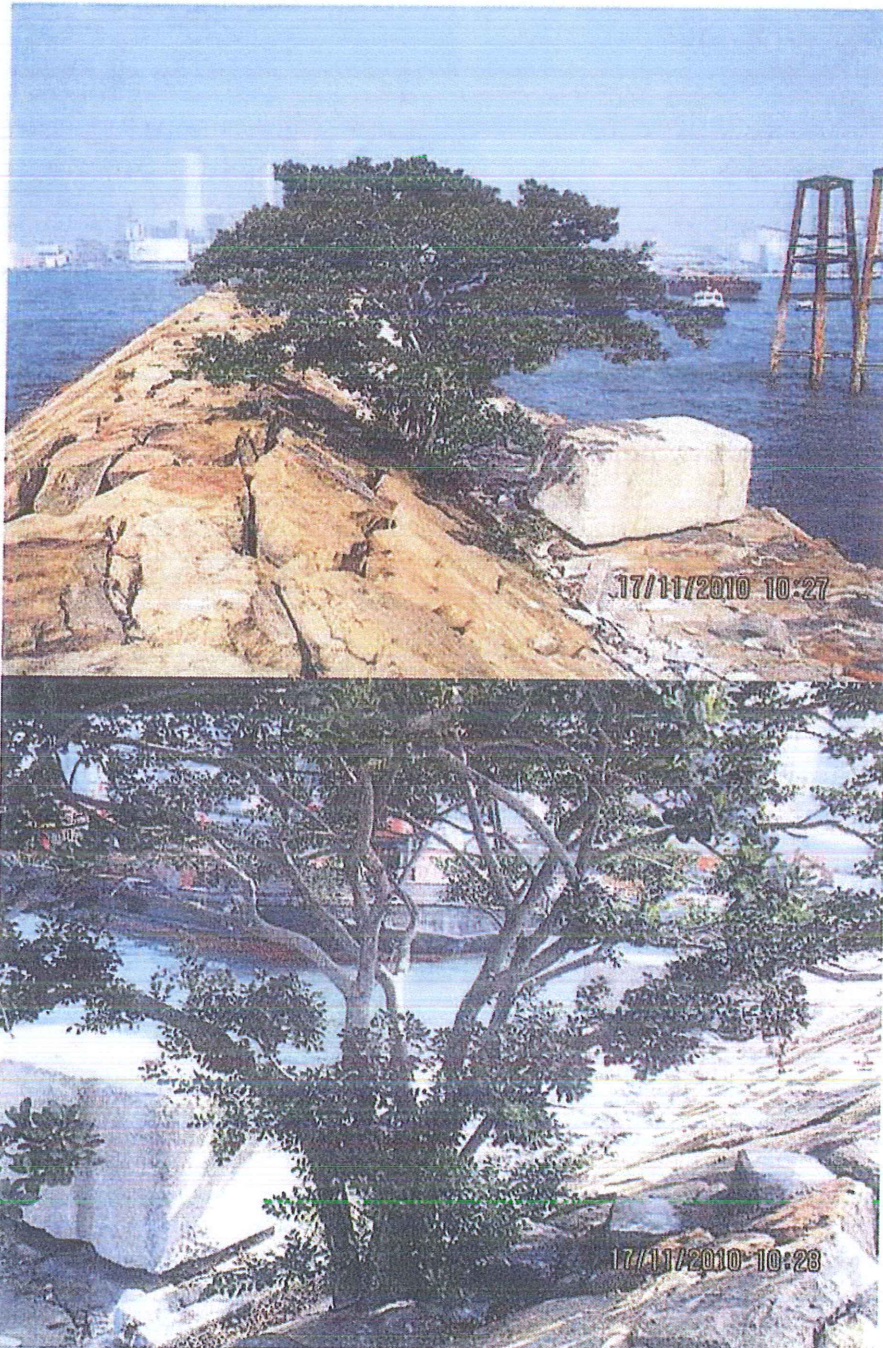
(n) Tree no. T2015 - *Ficus microcarpa* 榕樹, 細葉榕

Root system has developed at a 45 degree slope elevation in rocks.  
Root system distorted due to confined growing space between rocks.

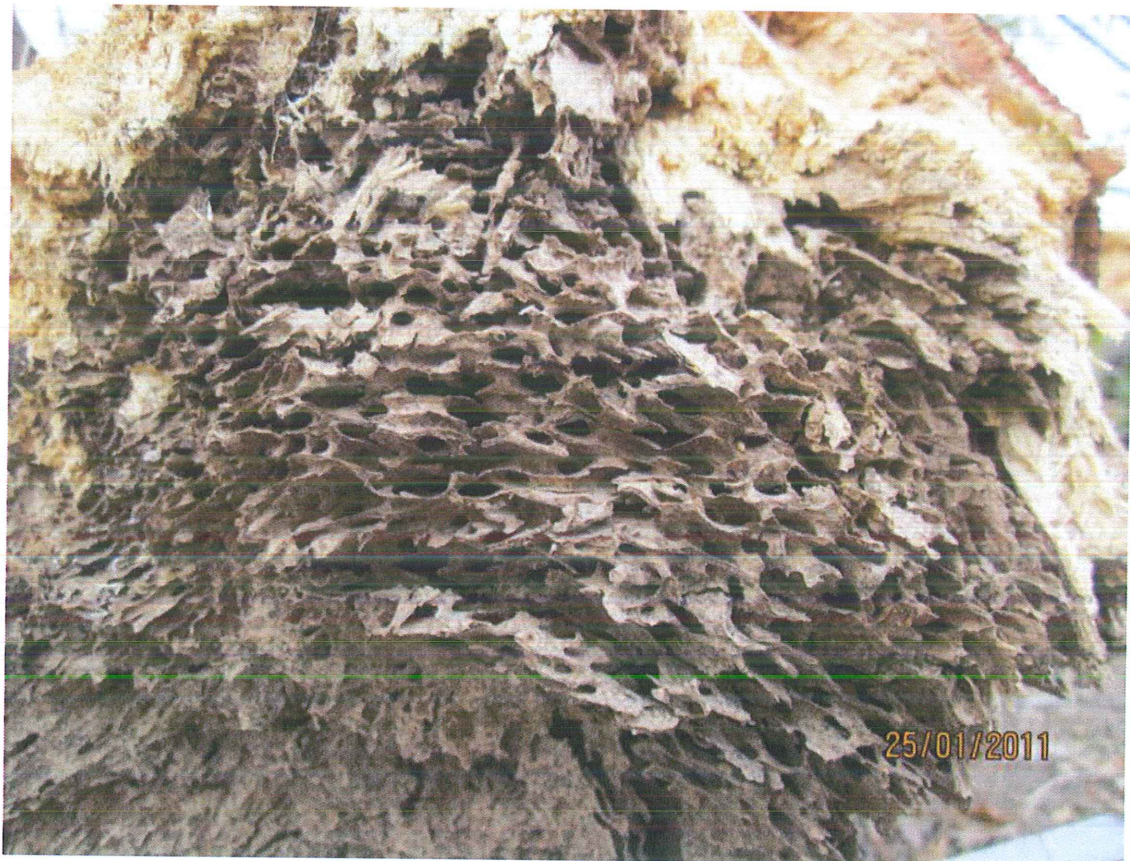
Tree No. T1905

Termite nest
