Contract No. HK/2012/08
Wan Chai Development Phase II -
Central - Wan Chai Bypass at Wan Chai West

Submission of Landscape Plan (Final) (Rev. 5) under Further Environmental Permit No.: FEP-12/364/2009/D (Formerly FEP-09/364/2009/B)

Under Condition 2.14 of Part C of the FEP-12/364/2009/D, a landscape plan has to be prepared and deposited by the permit holder to the EPD at least one month before the commencement of corresponding parts of landscape works of the Project.

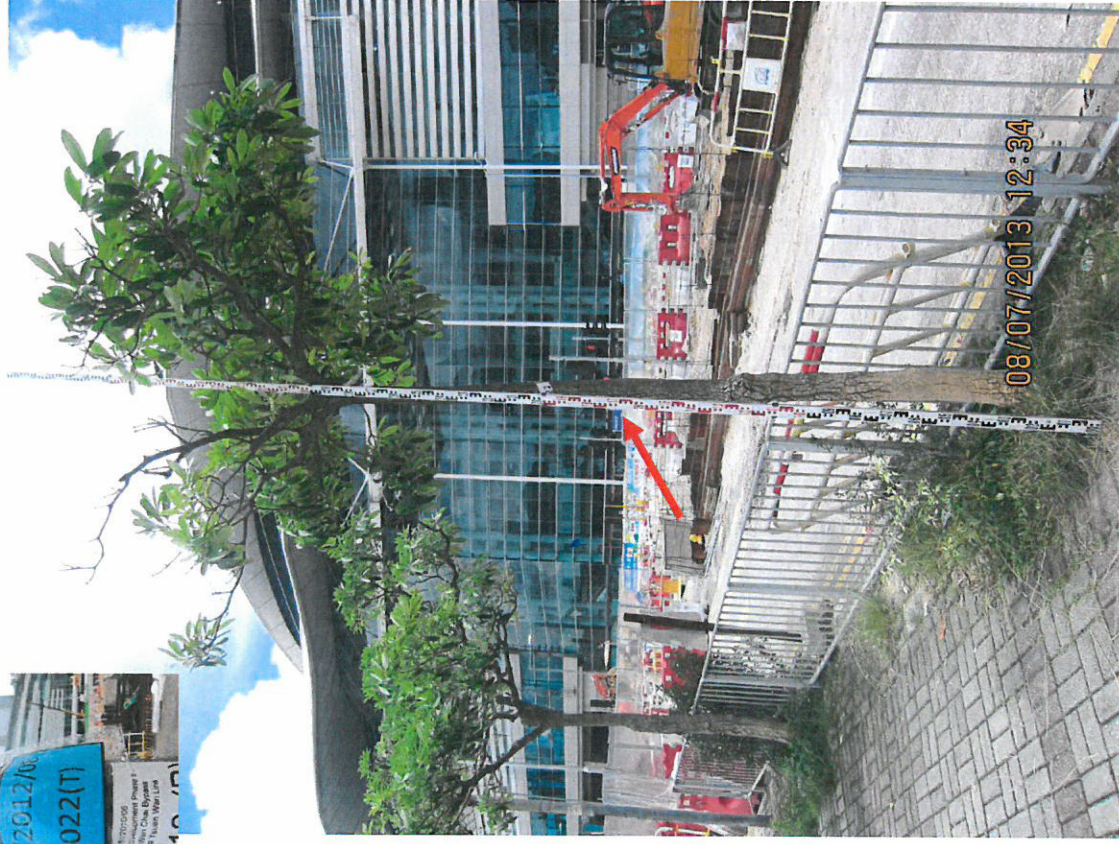
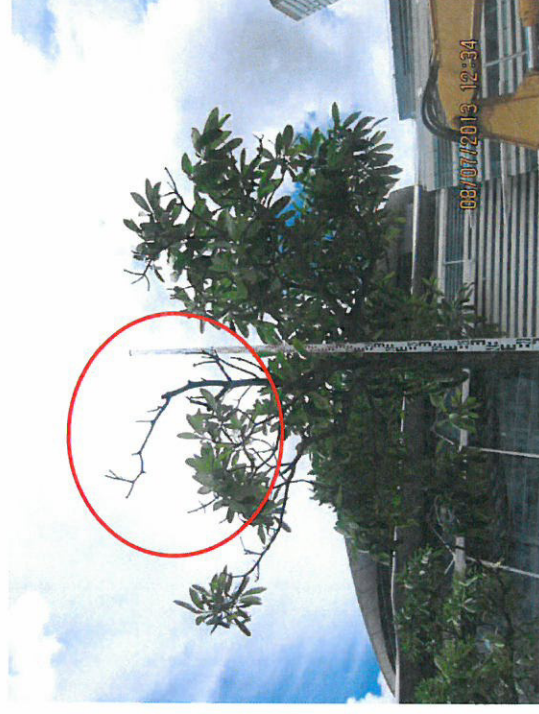
Tree No.: A022

A022	糖膠樹	<i>Alstonia scholaris</i>	96	2	3.5	Poor	Poor	+5.85mPD	Transplant	Dieback, paved pit	-
	A134	糖膠樹	<i>Alstonia scholaris</i>	86	1.5	4	Poor	Poor	+6.01mPD	Fell	Imbalanced tree form, wounds, paved pit, felled on 29-7-2013	-
	A135	糖膠樹	<i>Alstonia scholaris</i>	92	2	4	Fair	Fair	+5.98mPD	Transplant	Paved pit	-
	A136	糖膠樹	<i>Alstonia scholaris</i>	108	2	4.5	Fair	Fair	+5.88mPD	Transplant	Missing on tree plan and transplanted to holding nursery	-
	T0133	-	-	-	-	-	-	-	+5.81mPD	Transplant	Transplanted and maintained under Contract No. HK/2009/01	-
	T0134	-	-	-	-	-	-	-	+5.81mPD	Transplant	Transplanted and maintained under Contract No. HK/2009/01	-
	T0154	糖膠樹	<i>Alstonia scholaris</i>	162	3	5	Fair	Fair	+6.07mPD	Transplant	Dieback, imbalanced tree form, paved pit	-
	T0155	糖膠樹	<i>Alstonia scholaris</i>	137	3	3.5	Fair	Fair	+5.86mPD	Transplant	Dieback, paved pit	-
	T0156	糖膠樹	<i>Alstonia scholaris</i>	153	3.5	4.5	Fair	Fair	+6.17mPD	Transplant	Dieback, dead branches, paved pit	-

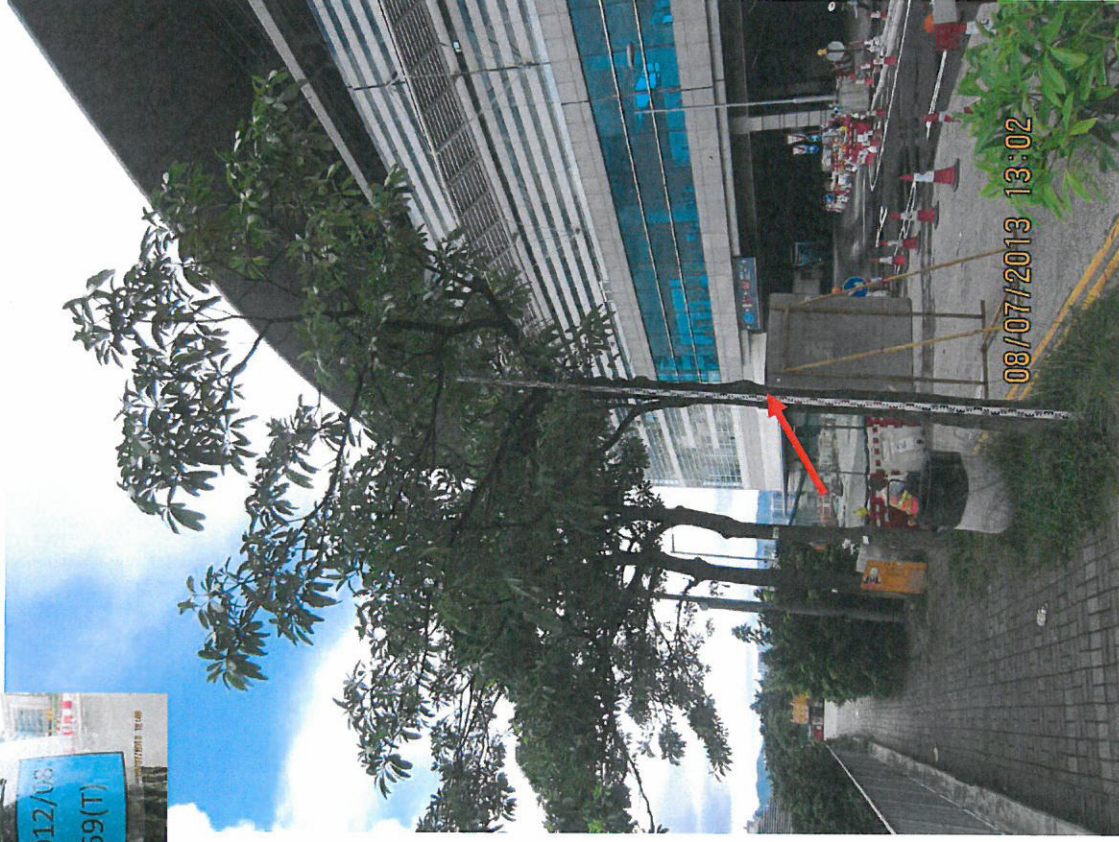
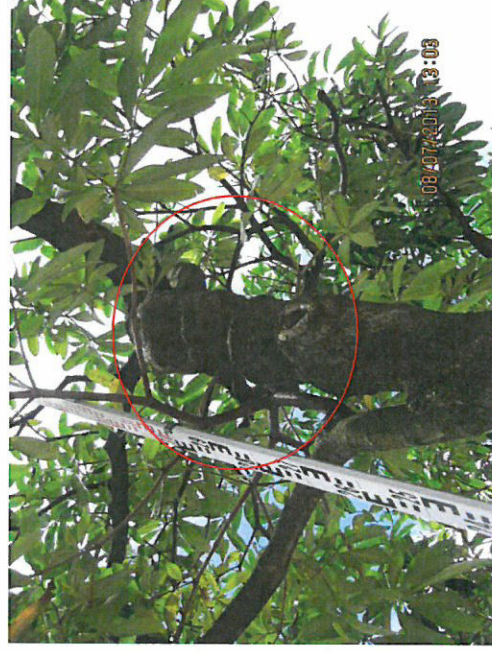
Tree No.: T0469

T0469	糖膠樹	<i>Alstonia scholaris</i>	172	3.5	5	Fair	Fair	+5.65mPD	Transplant	Wounds on trunk, paved pit	-
	T0471	糖膠樹	<i>Alstonia scholaris</i>	159	3	4	Fair	Fair	+5.67mPD	Transplant	Imbalanced tree form, dead branches, paved pit	-
	T0472	糖膠樹	<i>Alstonia scholaris</i>	140	2	2.5	Poor	Poor	+5.69mPD	Transplant	Dieback, topped, paved pit	Pending approval by DLO for tree removal
	T0473	糖膠樹	<i>Alstonia scholaris</i>	127	3	3.5	Fair	Fair	+5.71mPD	Transplant	Dieback, paved pit	-
	T0474	糖膠樹	<i>Alstonia scholaris</i>	153	4	3	Fair	Fair	+5.75mPD	Transplant	Dieback, paved pit, decayed wound	-
	T0475	糖膠樹	<i>Alstonia scholaris</i>	210	4	5	Fair	Fair	+5.78mPD	Transplant	Imbalanced tree form, paved pit	-
	T0476	糖膠樹	<i>Alstonia scholaris</i>	150	2	4	Poor	Poor	+5.82mPD	Transplant	Paved pit	-
	T0477	糖膠樹	<i>Alstonia scholaris</i>	213	3	4.5	Poor	Poor	+5.85mPD	Transplant	Included bark, pests on branch, paved pit, wounds on trunk	-

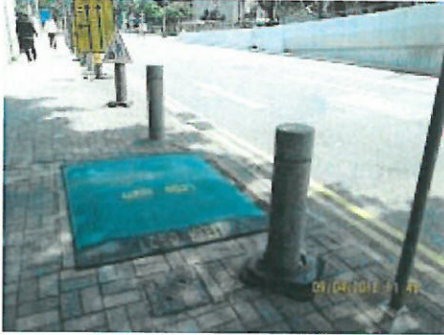
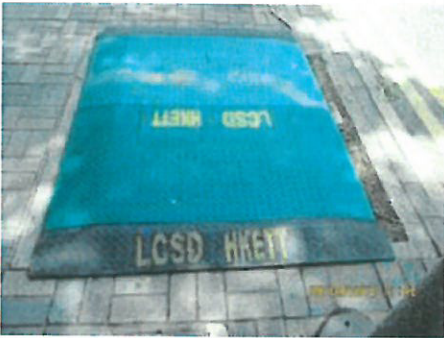
T0600 was felled.jpg
724K

We found that the tree T0600 *Aleurites Moluccana* near Fleet Arcade was felled (photos as attached).

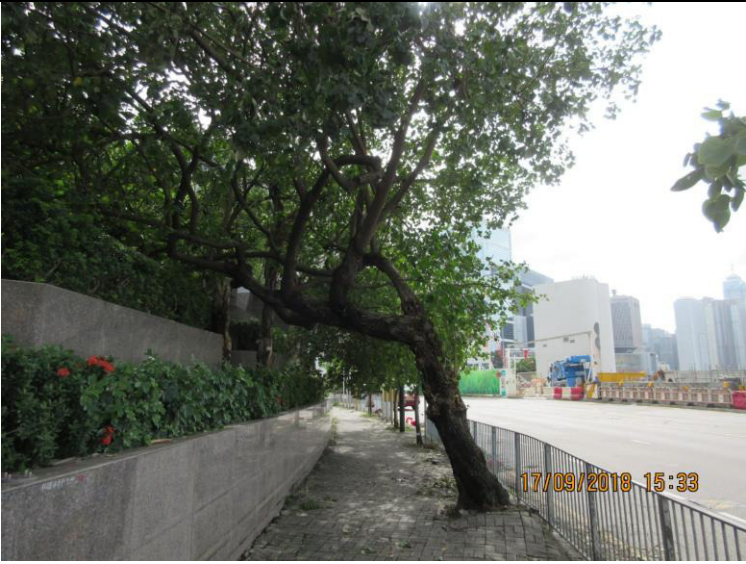
Photo No.	Tree Photo Record for T0495 at Convention Avenue	Date of Photo Taken
1

Please find attached photos of the tree (T0495) (*Hibiscus tiliaceus*) for your reference. It was observed that the tree was damaged after Typhoon Mangkhut on 16 Sep 2018 and the tree was removed subsequently. Grateful if you could advise if the tree was removed by LCSD and on what date for our record only.

<p data-bbox="418 919 1115 953">Tree leaning after Typhoon Mangkhut on 16 Sep 2018</p>	17 Sep 2018
2

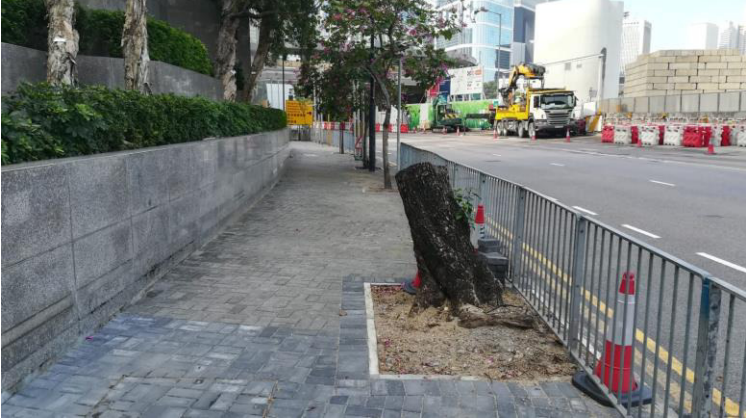
<p data-bbox="483 1373 1050 1409">The tree was felled by LCSD on 15 Nov 2018</p>	30 Nov 2018

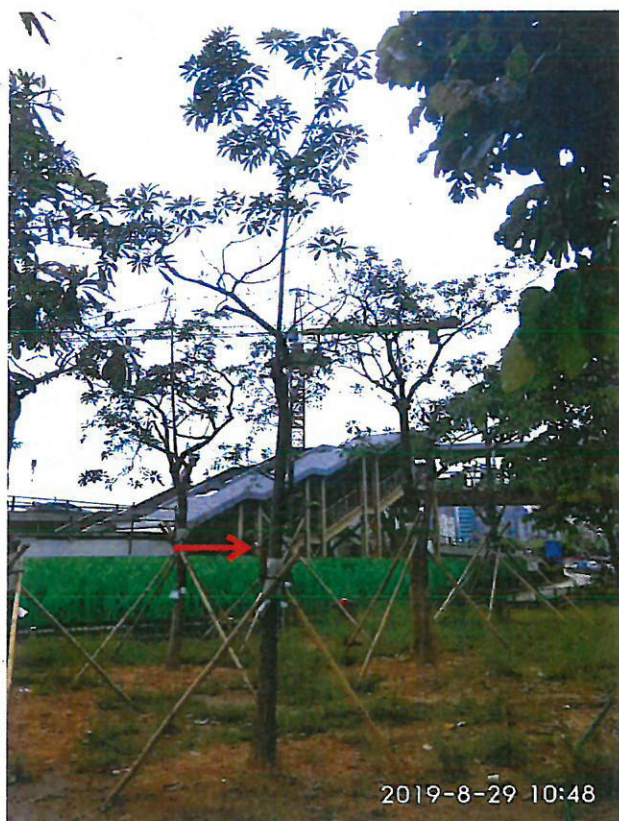
A021

2.0	<u>Inspection and Discussion</u>	
2.1	The trees above were inspected by LCSD and the attended parties on 29 August 2019. Please refer to Appendix B for the record photographs.	Noted

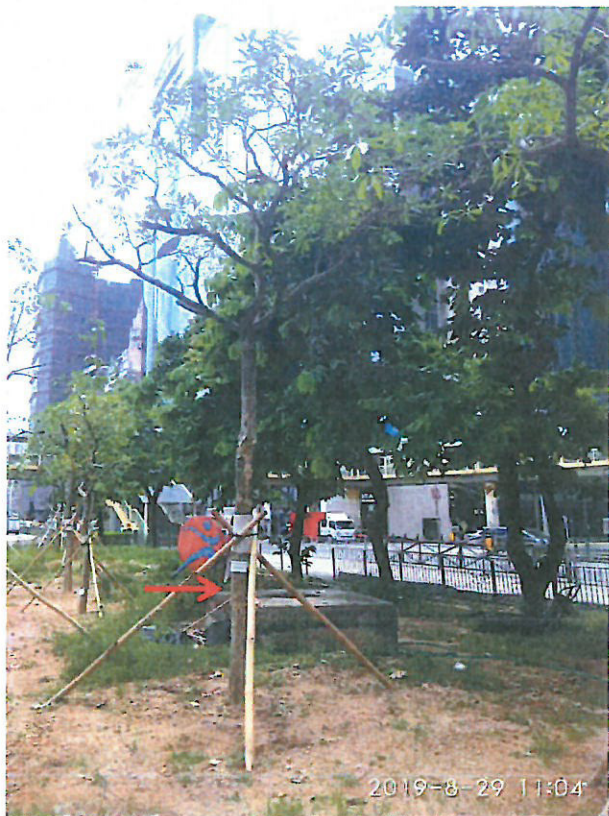
However, **Trees No. T472 and T490** were not acceptable to LCSD due to major structure defects. AACL advised that tree felling application would be submitted to Lands Department for **Trees No. T472 and T490**.

<p>Major structural defect as commended by LCSD:</p> <ul style="list-style-type: none"> - hollowed tree; and - initial sound test revealed that the hollow was developed from ground level to about 1m above ground.
T490

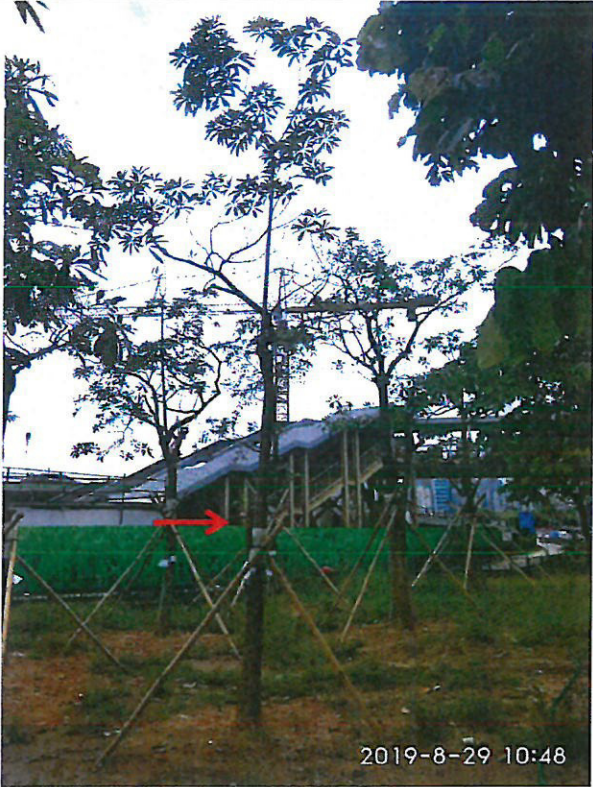
Tree No.	Tree Photo	Remarks
A021

<p>Fair Heath and Form, better than the last inspection on 24 July 2019.</p> <p>LCSD reminded that the dead branches shall be removed as the tree treatment method</p>
Tree No.	Tree Photo	Remarks
A170

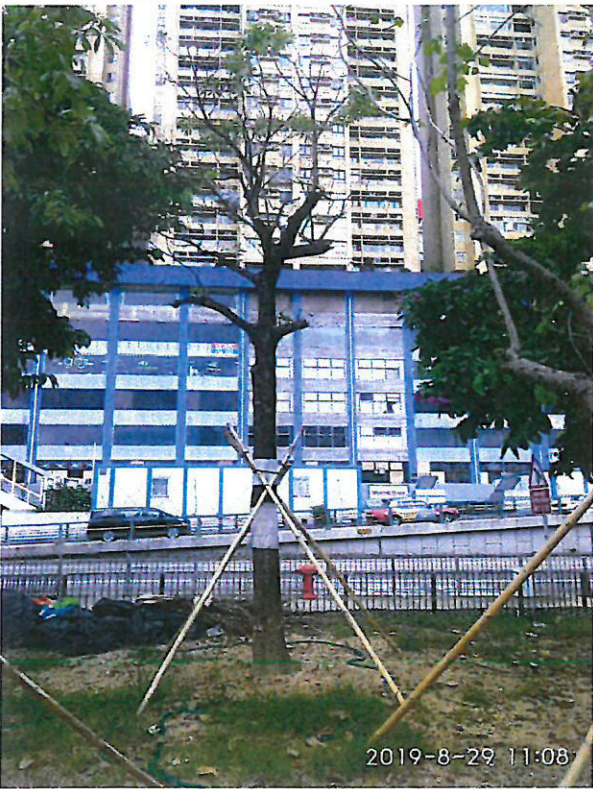
<p>Fair Heath and Form, better than the last inspection on 24 July 2019.</p> <p>LCSD reminded that the dead branches shall be removed as the tree treatment method</p>

2.3	After 1 month of observation period to 5 nos. of transplanted trees (A021, T170, T469, T487 and T488) since 24 July 2019, the tree conditions were acceptable to LCSD. LCSD advised that the dead branches should be removed during establishment period.	AACL / CSLJV

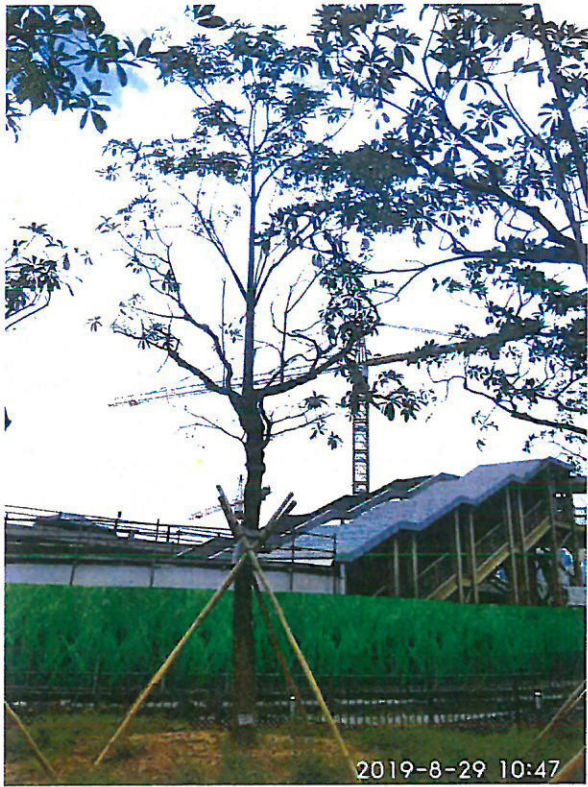
Tree No.	Tree Photo	Remarks
T469

<p>Fair Heath and Form, better than the last inspection on 24 July 2019.</p> <p>LCSD reminded that the dead branches shall be removed as the tree treatment method</p>
Tree No.	Tree Photo	Remarks
T487

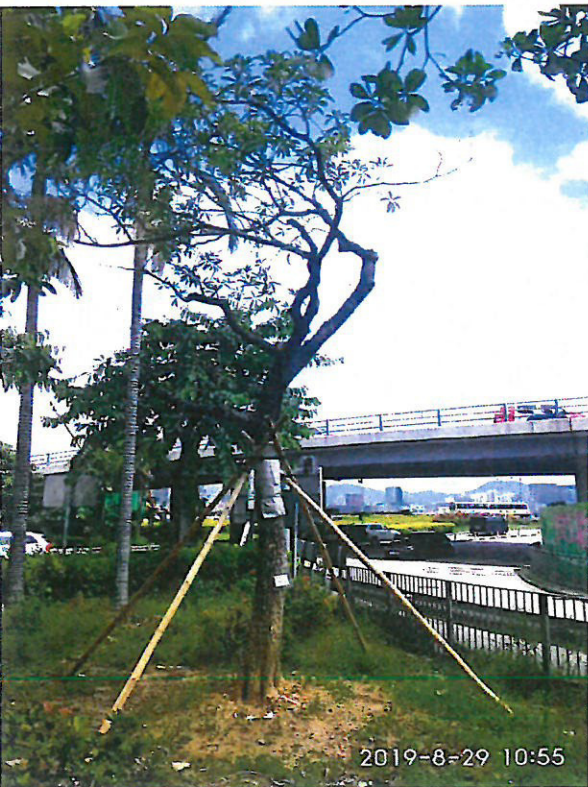
<p>Fair Heath and Form, better than the last inspection on 24 July 2019.</p> <p>LCSD reminded that the dead branches shall be removed as the tree treatment method</p>

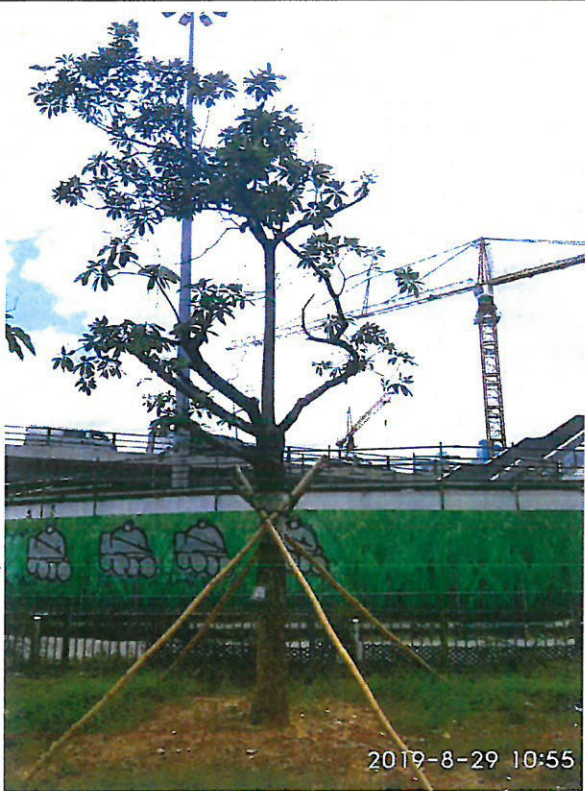
Tree No.	Tree Photo	Remarks
T488

Fair Heath and Form, better than the last inspection on 24 July 2019. LCSD reminded that the dead branches shall be removed as the tree treatment method

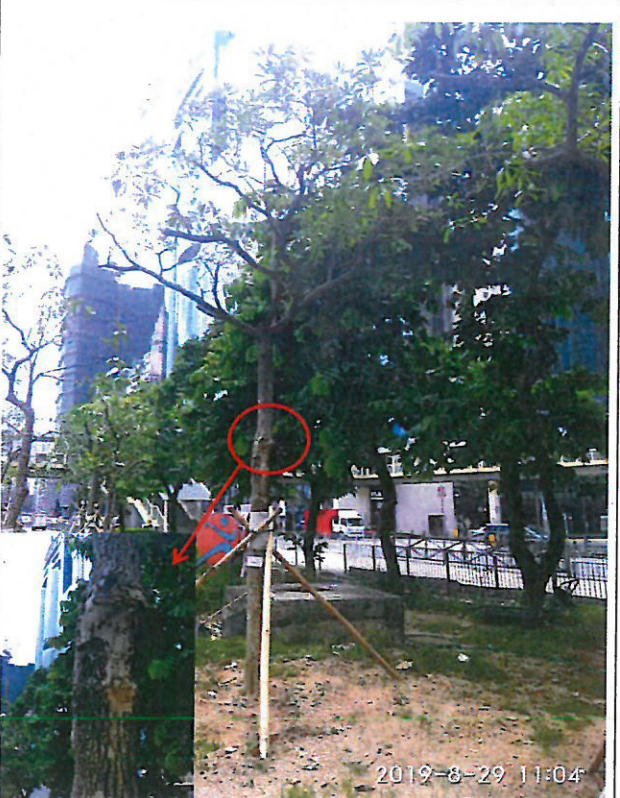
<p>Major structural defect found during last inspection on 24 July 2019:</p> <ul style="list-style-type: none"> - ringbarked tree trunk at about 1.8m above; - no significant improvement to the wound since last inspection

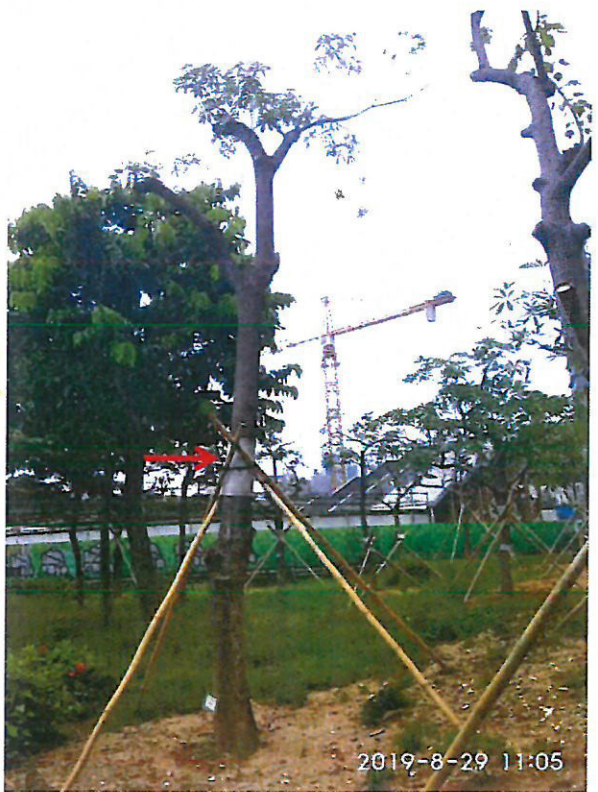
Tree No.	Tree Photo	Remarks
T605

<p>Fair Heath and Structure On 29 August 2019, tree no. T605 was acceptable to LCSD.</p>

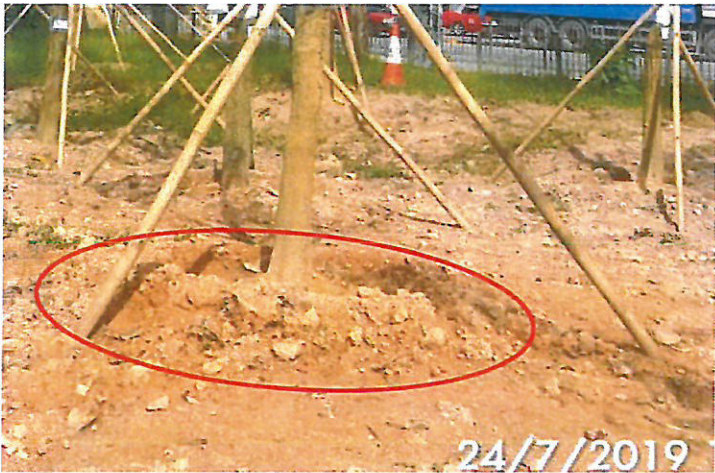
<p>1. Soil forming "soil ring" to be removed:</p>

2.2	Soil forming "soil ring" and stones at soil were removed. End of bamboo stakes were covered up to prevent stagnant water inside bamboo stakes. LCSD had no comment; Please refer to Appendix E for rectified photos.	Noted

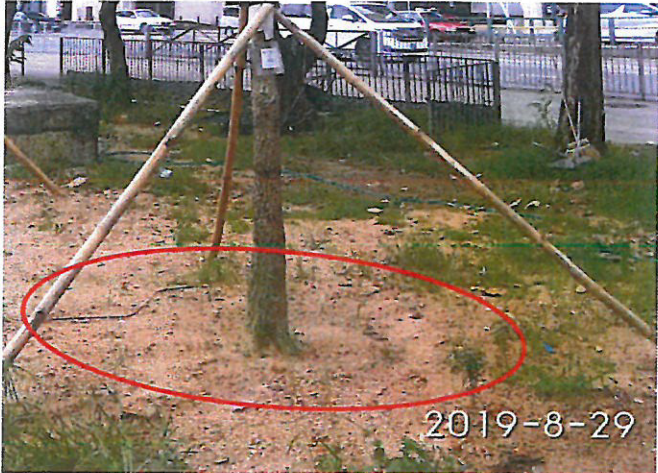
<p>Rectified.</p>

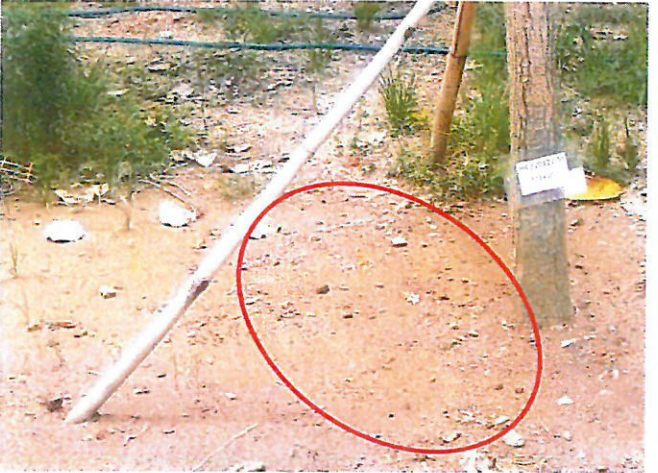
<p>2. Soil to be free from stones: and</p>

<p>Rectified.</p>

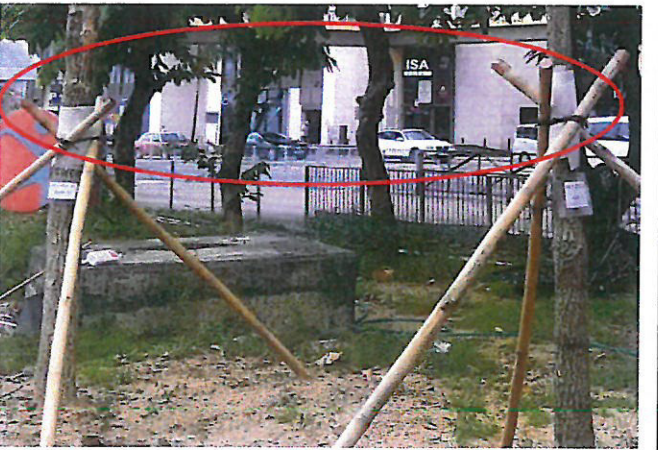
<p>3. Ends of bhamboo stake to be covered in a way that no stagnant water would be formed</p>

<p>Rectified.</p>
