CONTRACT NO: HK/2015/01

**WANCHAI DEVELOPMENT PHASE II AND CENTRAL
WANCHAI BYPASS
SAMPLING, FIELD MEASUREMENT AND TESTING WORK
(STAGE 3)**

**QUARTERLY ENVIRONMENTAL MONITORING
AND AUDIT REPORT**

- SEPTEMBER 2016 TO NOVEMBER 2016 -

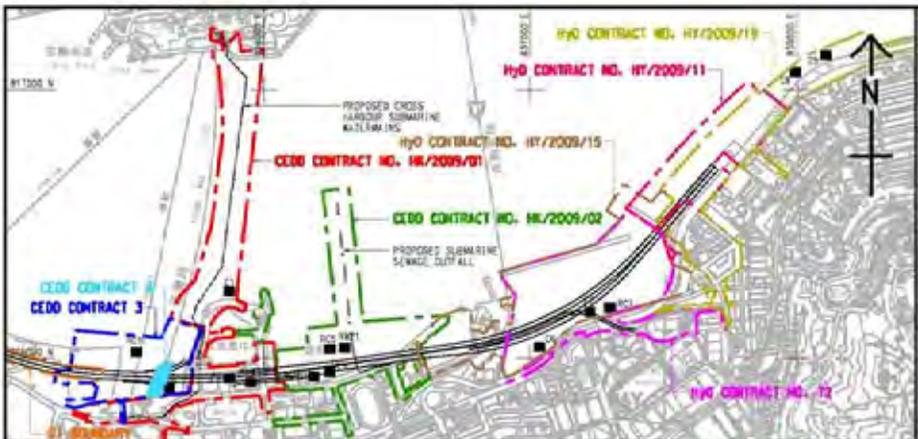
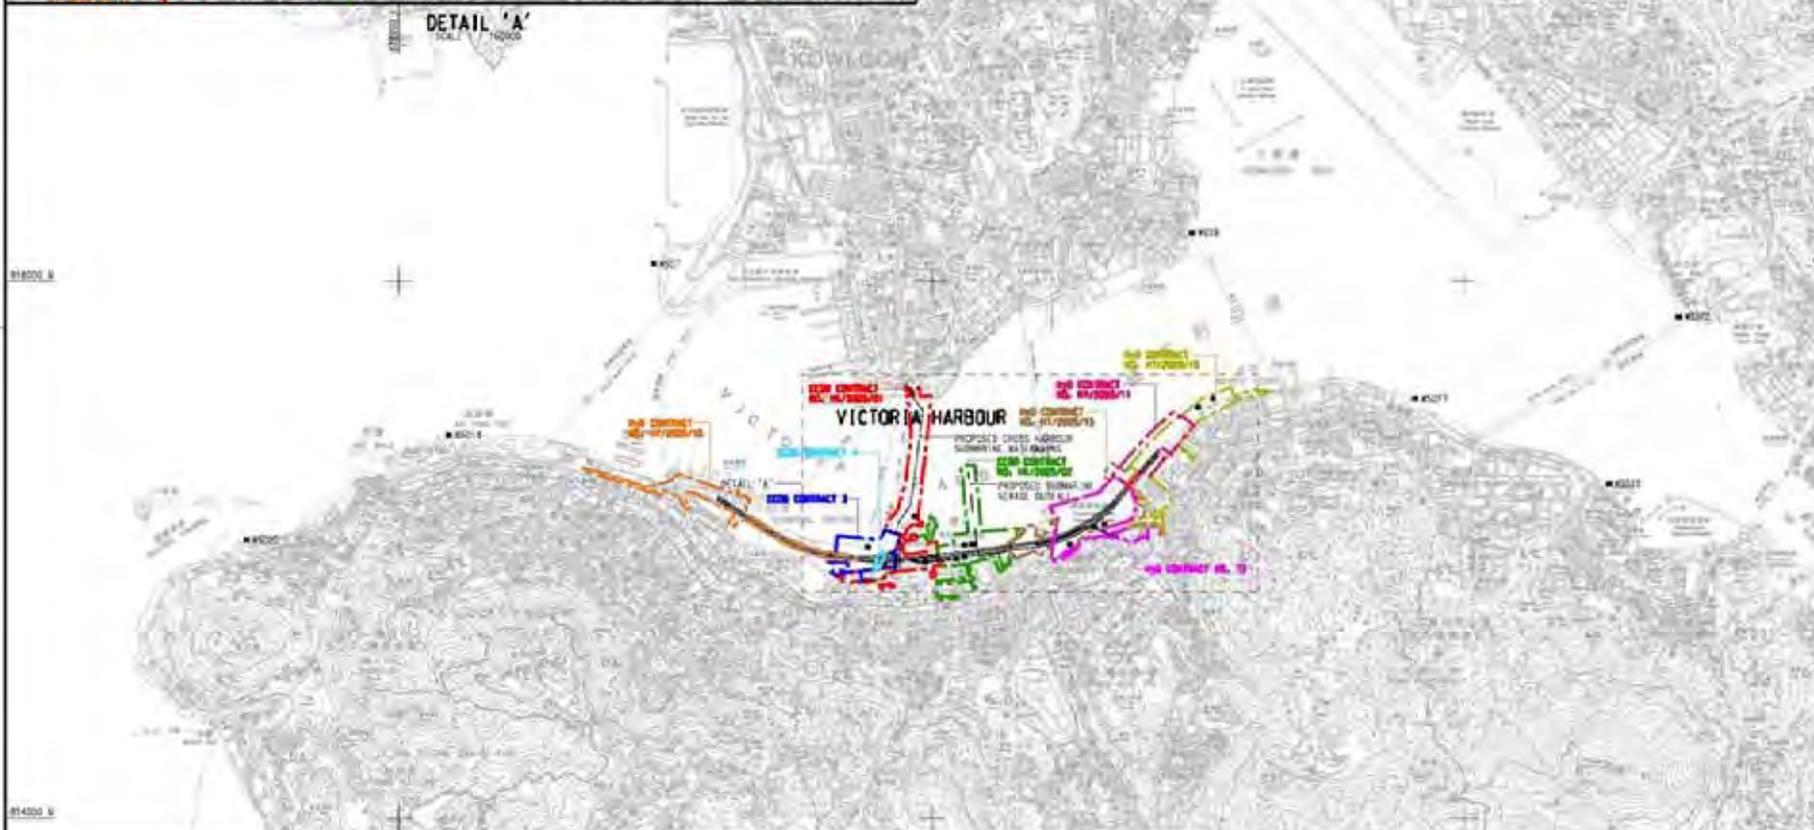
Figure 2.1

- 2.2.1. The Project is located mainly in Wan Chai North, Causeway Bay and North Point, and is demarcated by Gloucester Road and Victoria Park Road to the south, Fenwick Pier Street to the west and Tong Shui Road Interchange to the east, as shown in **Figure 2.1**.

Project Layout

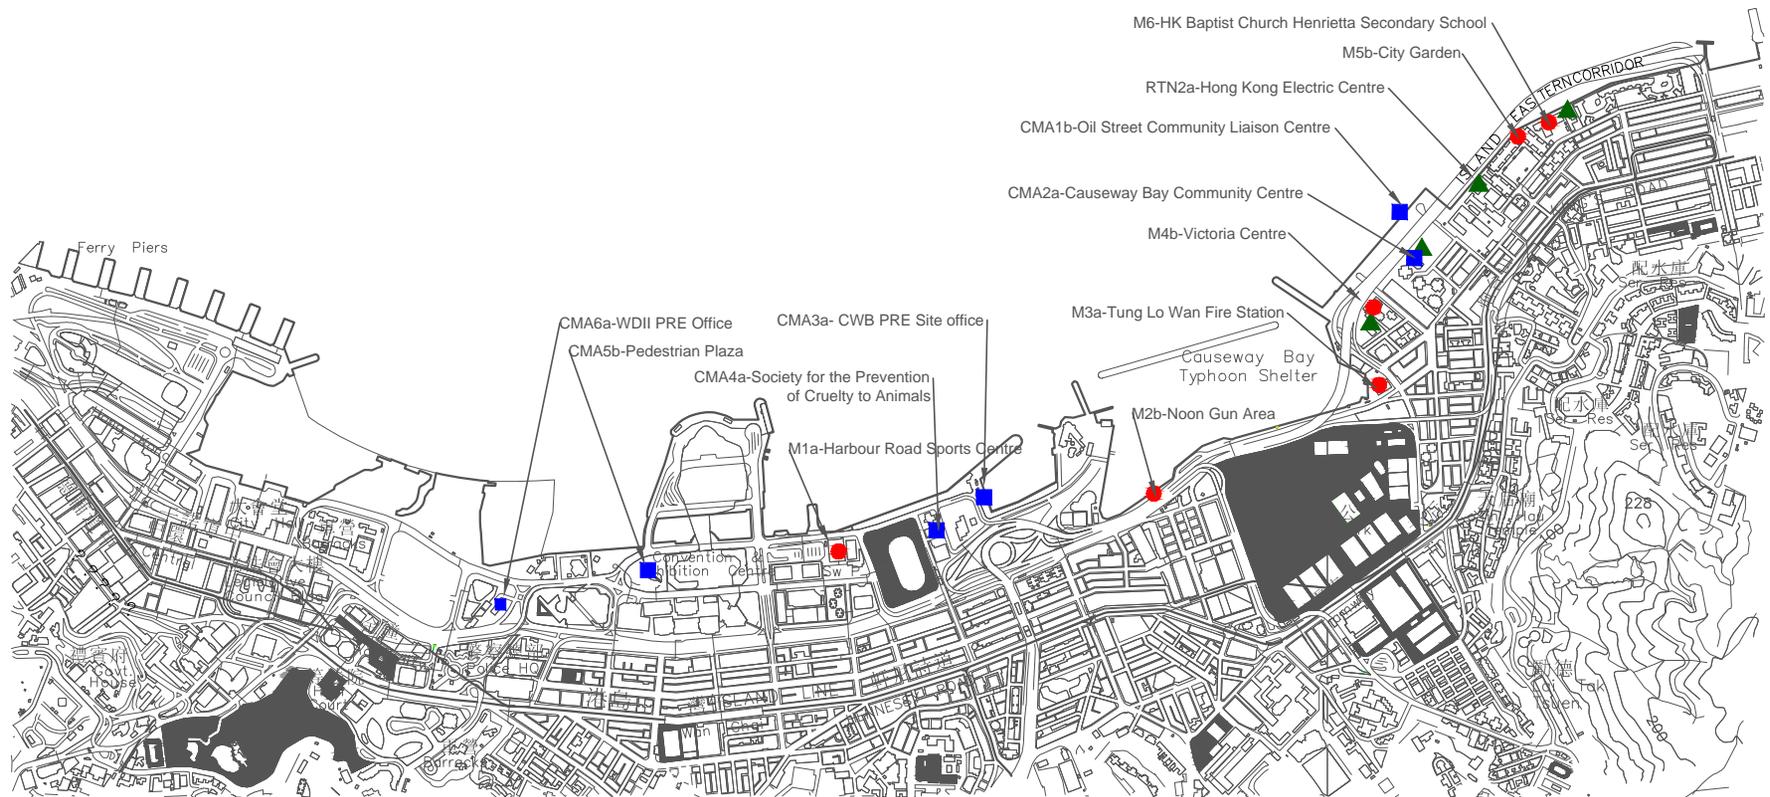
Figure 3.1

LOCATIONS OF AIR QUALITY AND NOISE MONITORING STATIONS

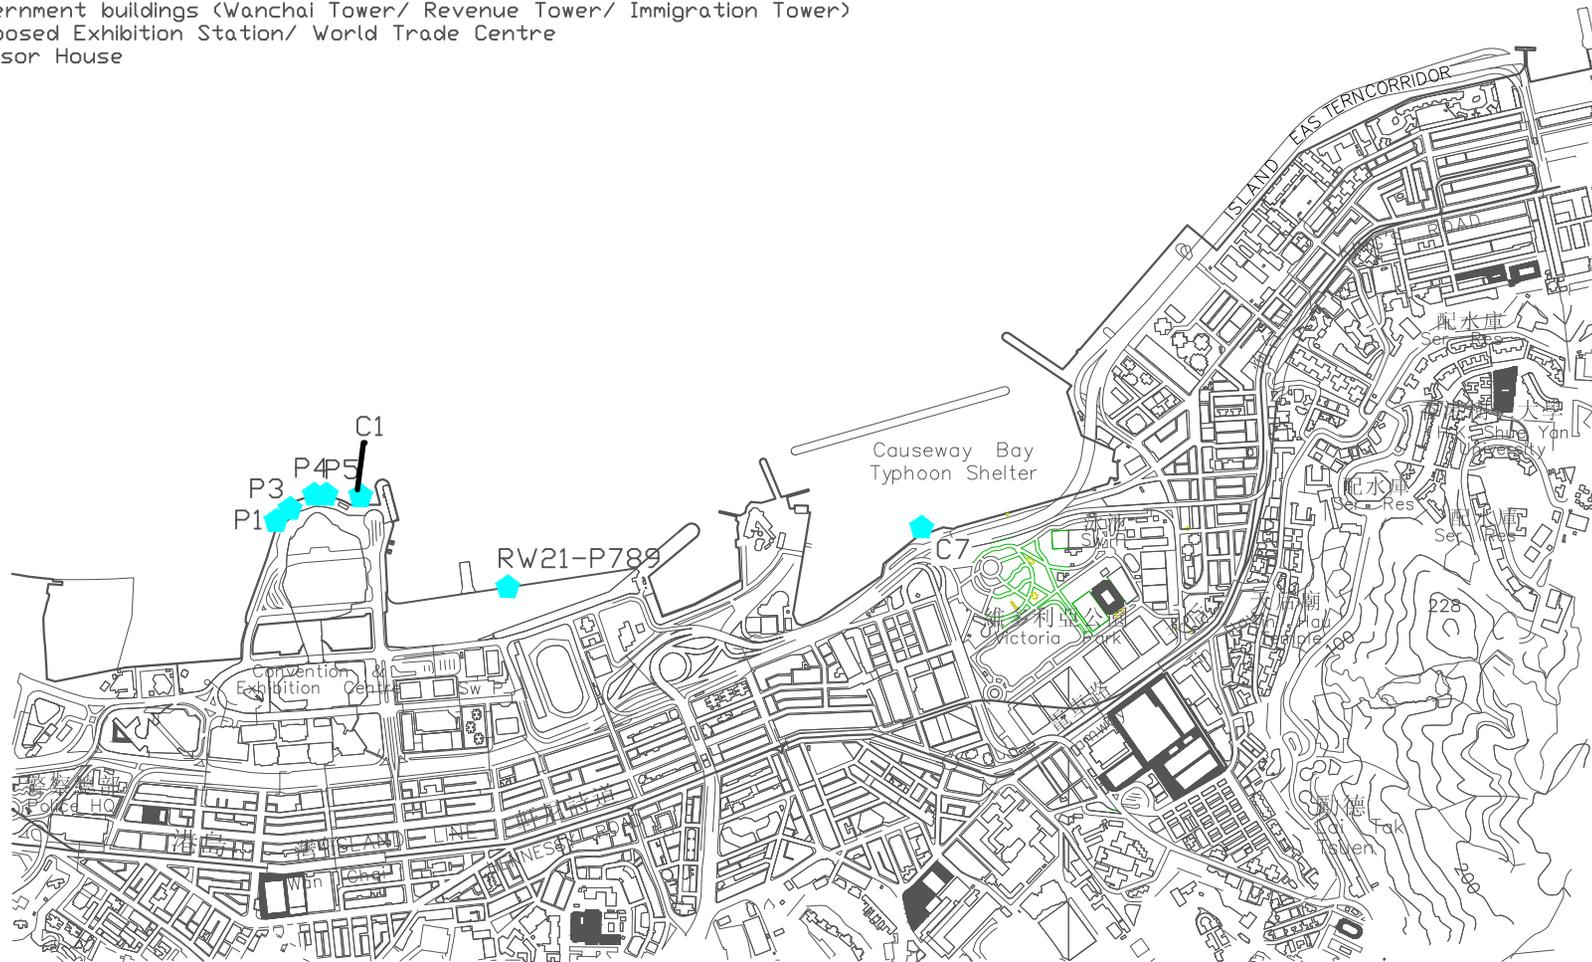
FIGURE

LOCATIONS OF WATER QUALITY MONITORING STATIONS

- 3.3.20 The enhanced water quality monitoring and audit programme is to avoid aggravation of odour nuisance from seawater arising from temporary reclamation in the ex-Wan Chai Public Cargo Working Area and the Causeway Bay Typhoon Shelter.
- 3.3.21 Dissolved oxygen monitoring at the intakes C6 and C7 in Causeway Bay Typhoon Shelter when there is temporary reclamation in Causeway Bay Typhoon Shelter and at the south-western and south-eastern corners of the ex-Wan Chai Public Cargo Working Area. The proposed water quality monitoring stations of the Project are shown in **Table 3.5** and **Figure 3.1**.

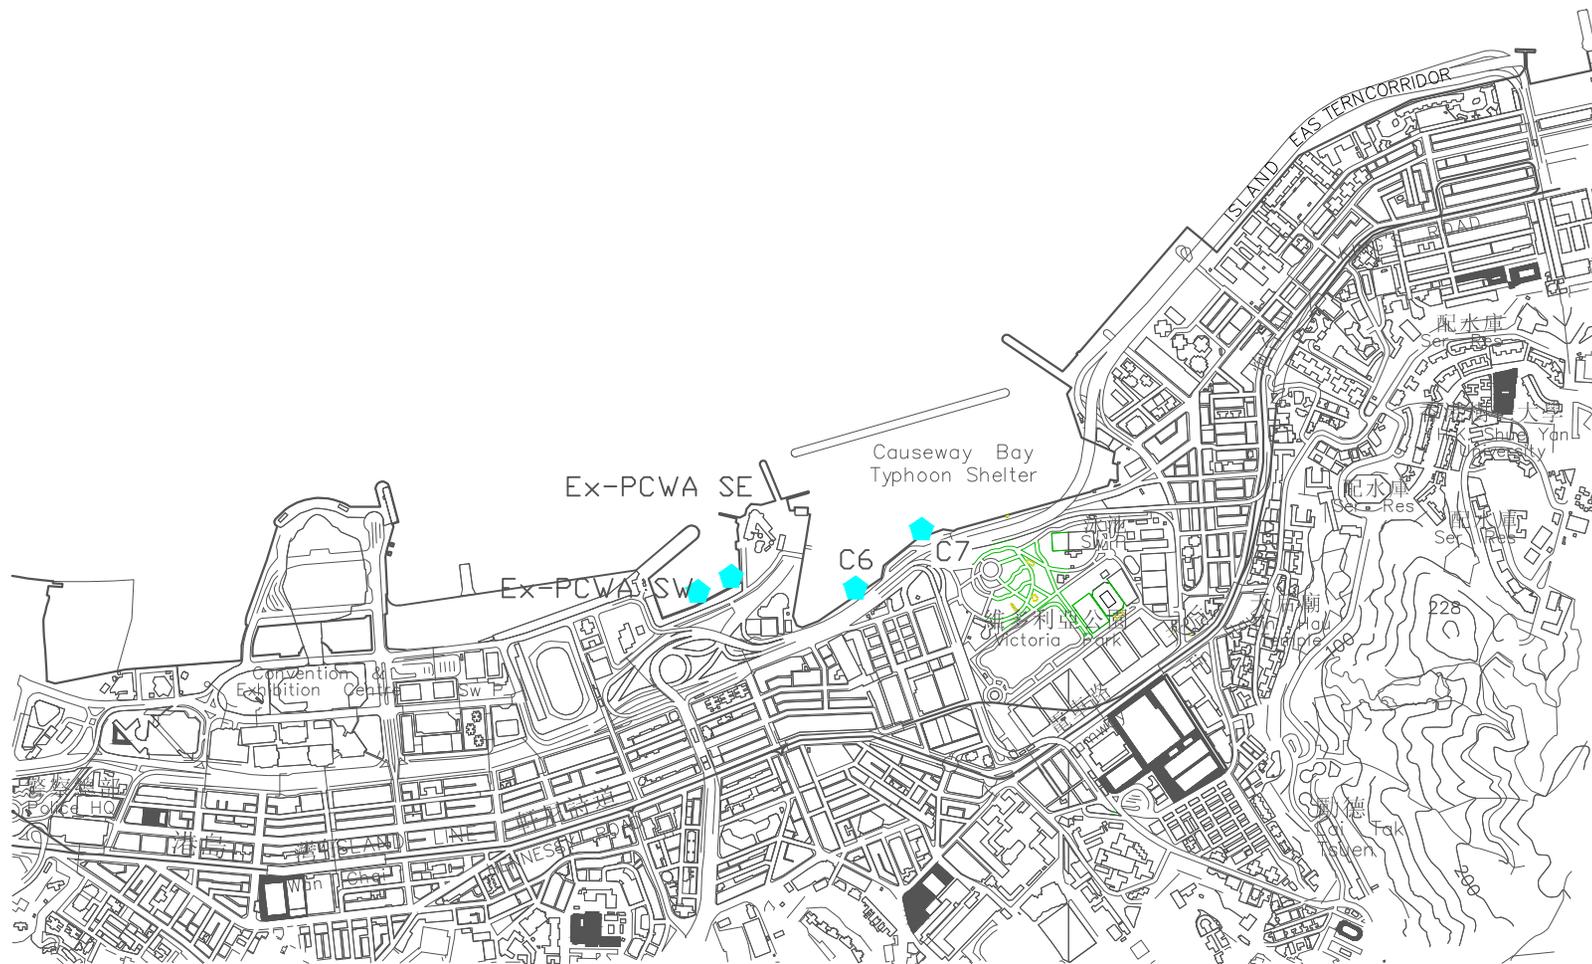
FIGURE

LOCATIONS OF ENHANCE DO MONITORING STATIONS

- xxxiii. Enhanced DO monitoring at 3 monitoring stations in Causeway Bay Typhoon Shelter and Ex-Public Cargo Works Area was conducted three days per week during the reporting period.
