**CONTRACT NO: HK/2011/07**

**WANCHAI DEVELOPMENT PHASE II AND CENTRAL  
WANCHAI BYPASS  
SAMPLING, FIELD MEASUREMENT AND TESTING WORK  
(STAGE 2)**

**MONTHLY ENVIRONMENTAL MONITORING & AUDIT REPORT**

**- AUGUST 2014 -**

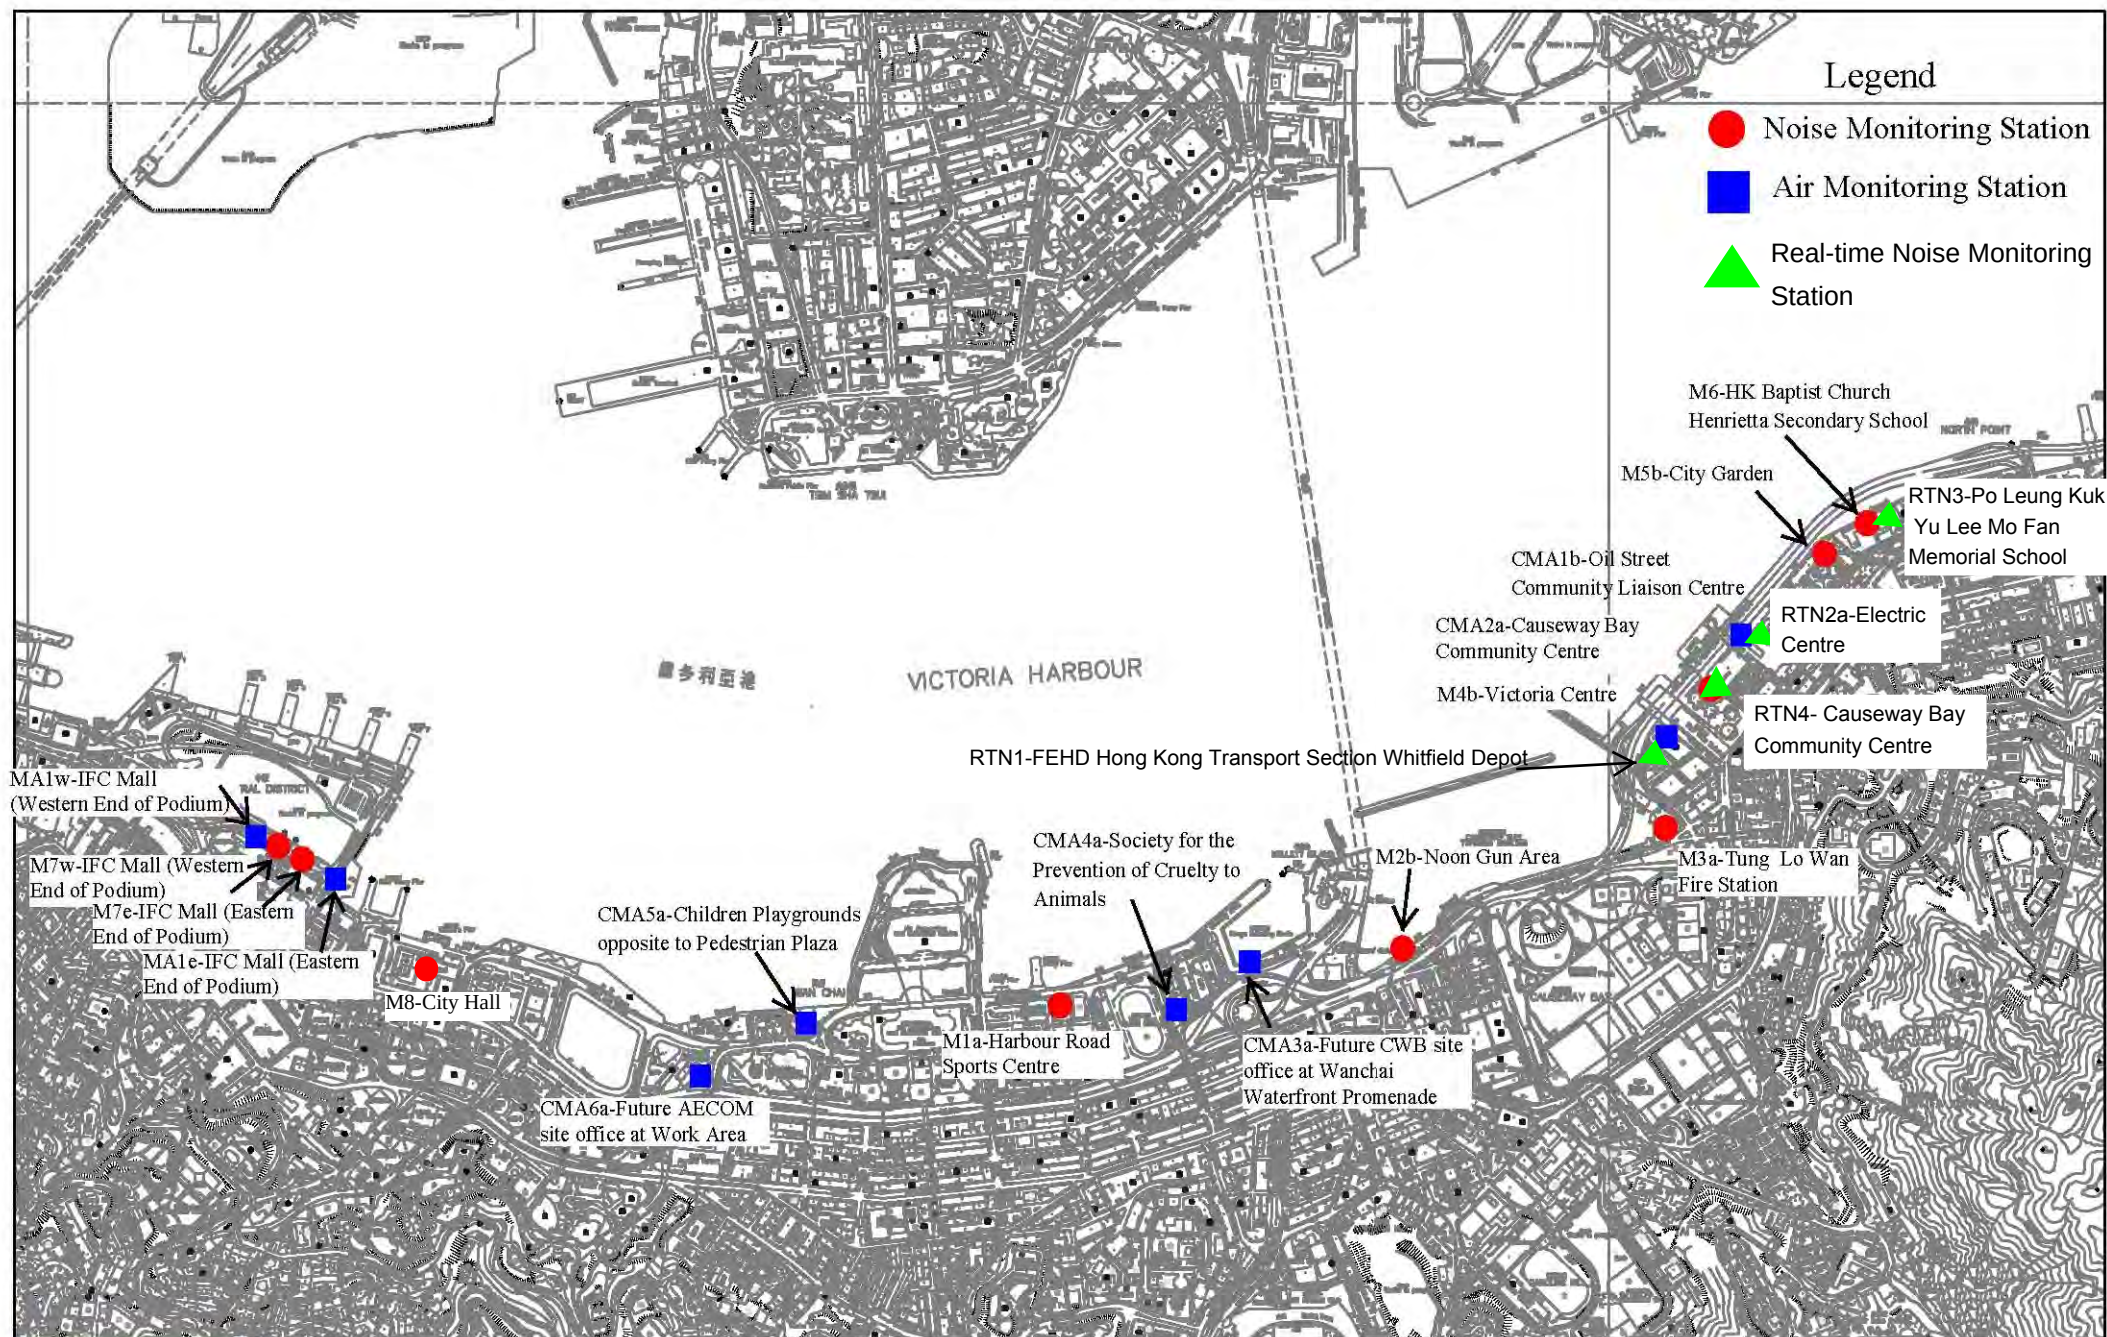
***Figure 4.1***

***Locations of Monitoring Stations***

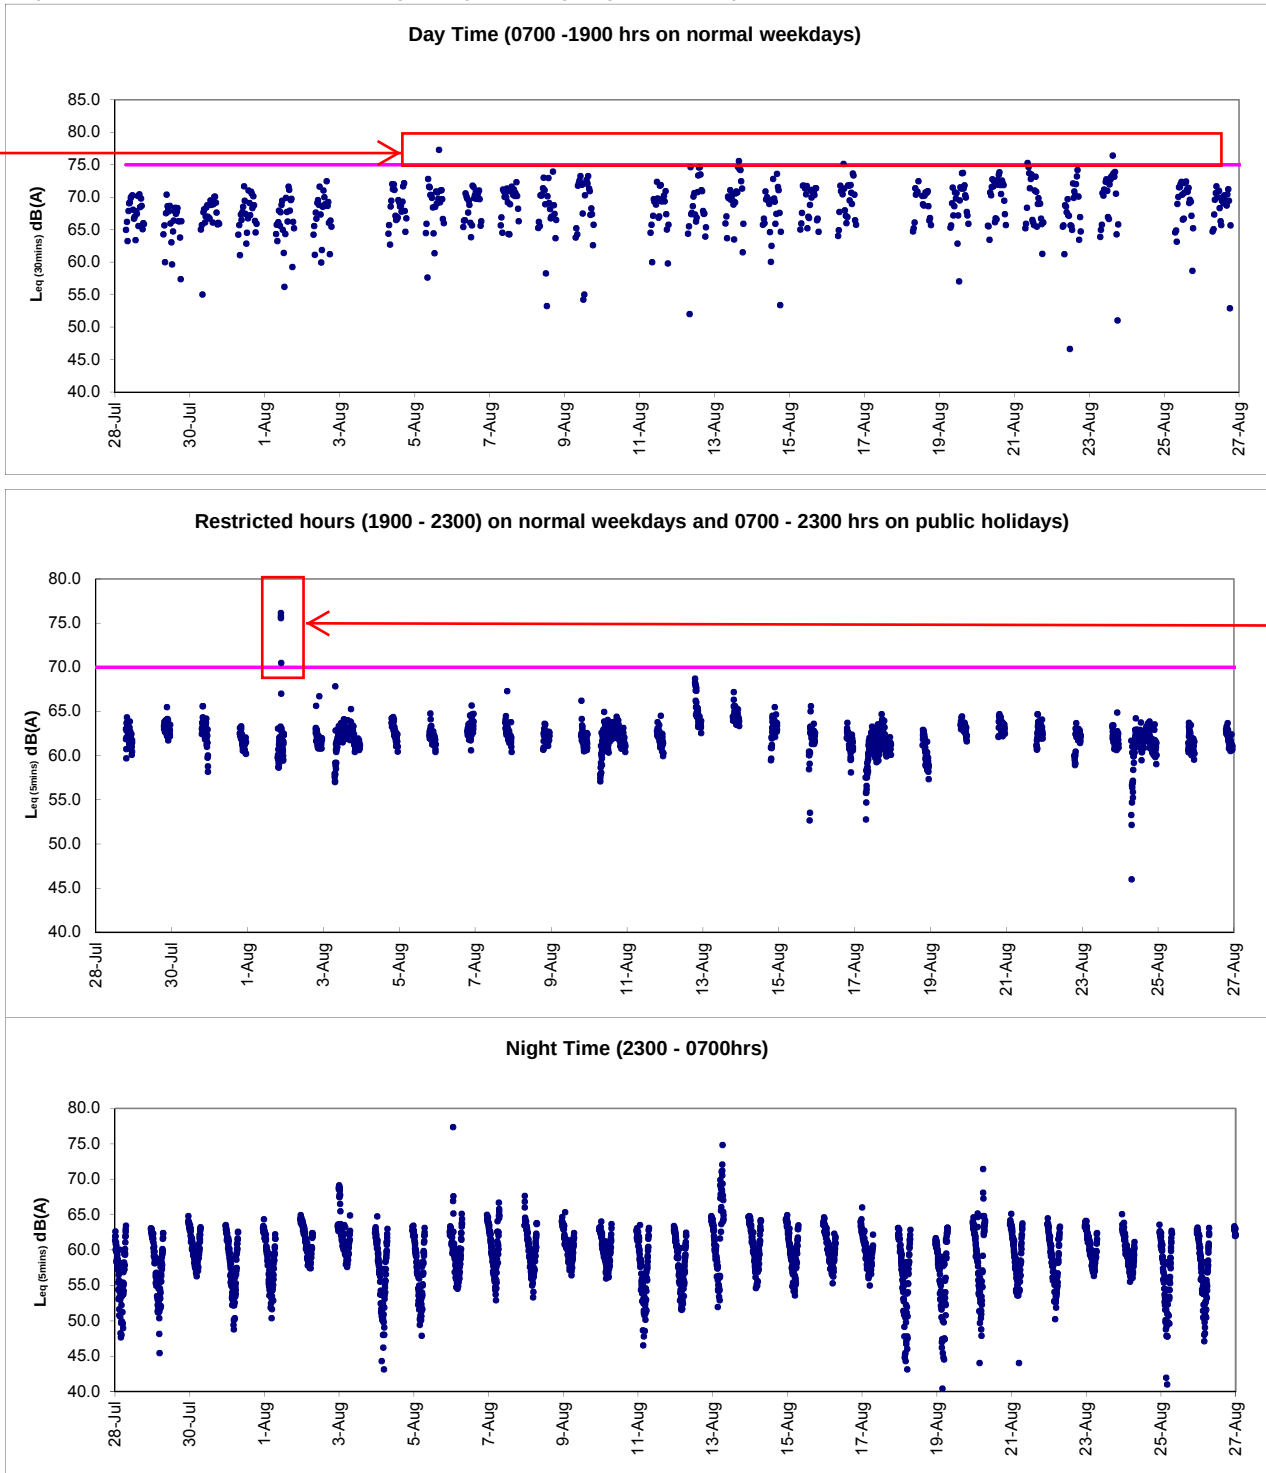
Graphic Presentation of Real Time Noise Monitoring Result (RTN2a- Hong Kong Electric Centre)

After checking with contractor HY/2009/19, despite bored piling works and occasionally breaking works were conducted, contractor mitigation measures including erection of temporary noise barrier was in place. In view of the exceedances are non-continuous, the exceedances are considered to be non-Project related and contributed by the IEC traffic and piling works at adjacent non-CWB piling site.

After checking with contractor HY/2009/19, bored piling work was conducted at the concerned location during the recorded period. Temporary noise barrier was implemented and CNP GW-RS0752-14 was in place and complied. The exceedance was considered to be contributed by nearby IEC traffic and not related to Project.
