**Contract No. HY/2009/15**

**Central – Wan Chai Bypass – Tunnel (Causeway Bay Typhoon Shelter Section)**

**Environmental Permit No.: FEP-06/364/2009/A – Landscape Plan (Revision 3)**

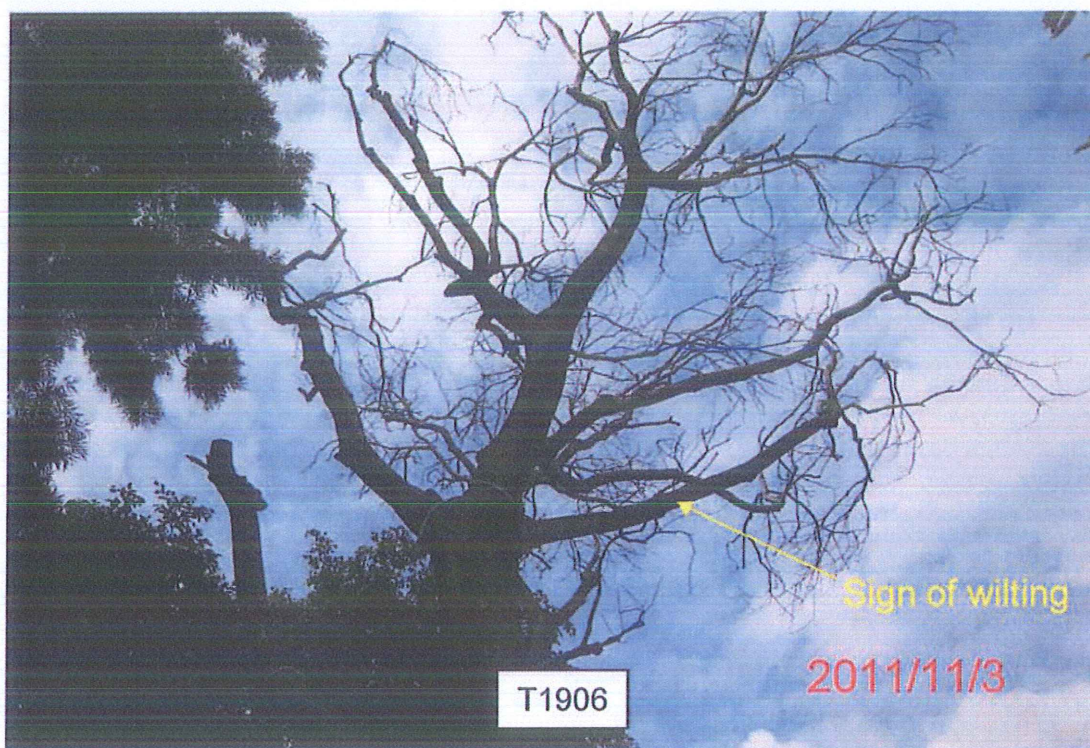
T1906 and T1907

Sign of wilting

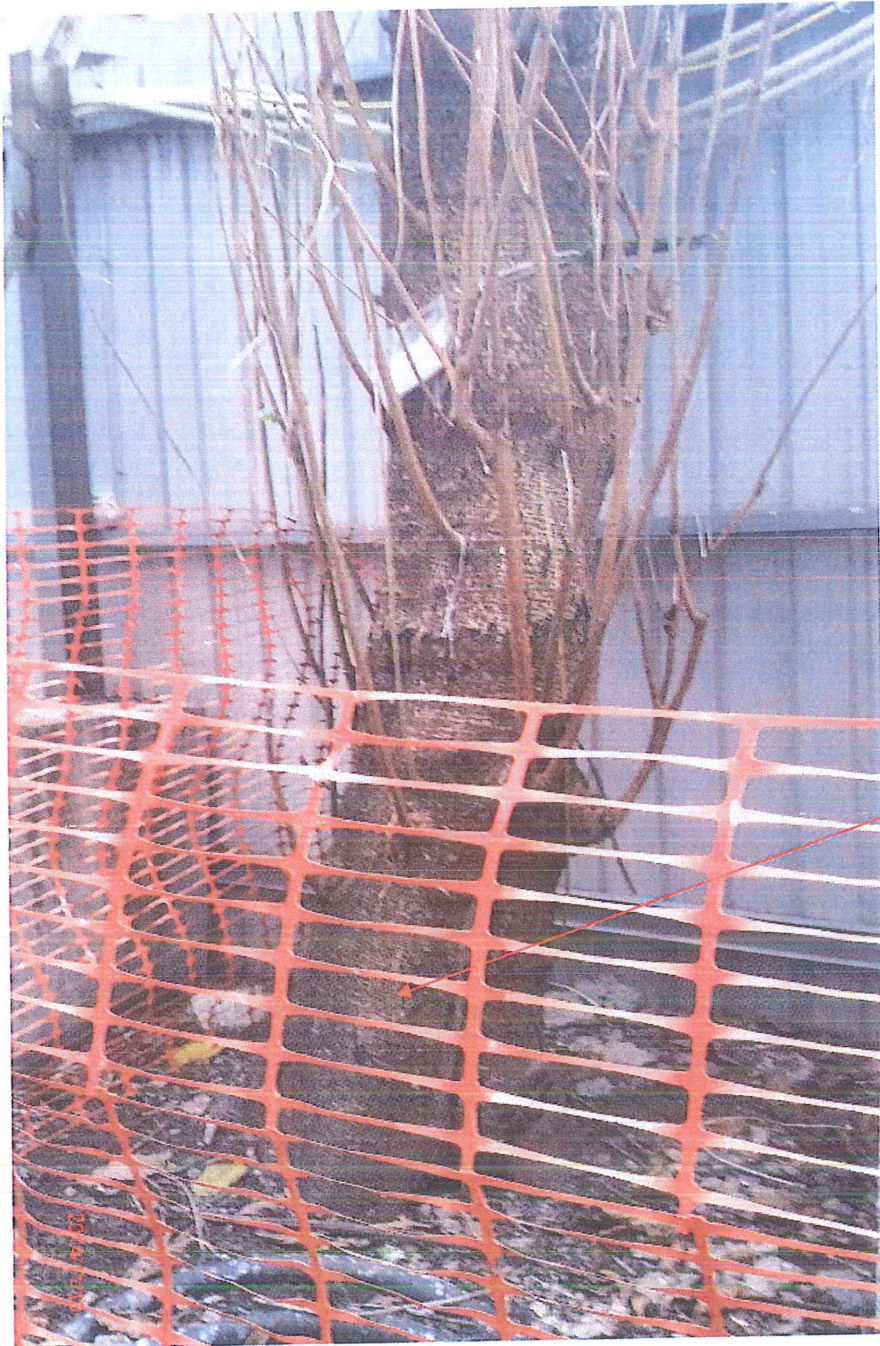
T1921 - *Morus alba* 桑

T1921 :  
Sign of  
decay –  
Minor  
(Tree  
condition  
under close  
observation)

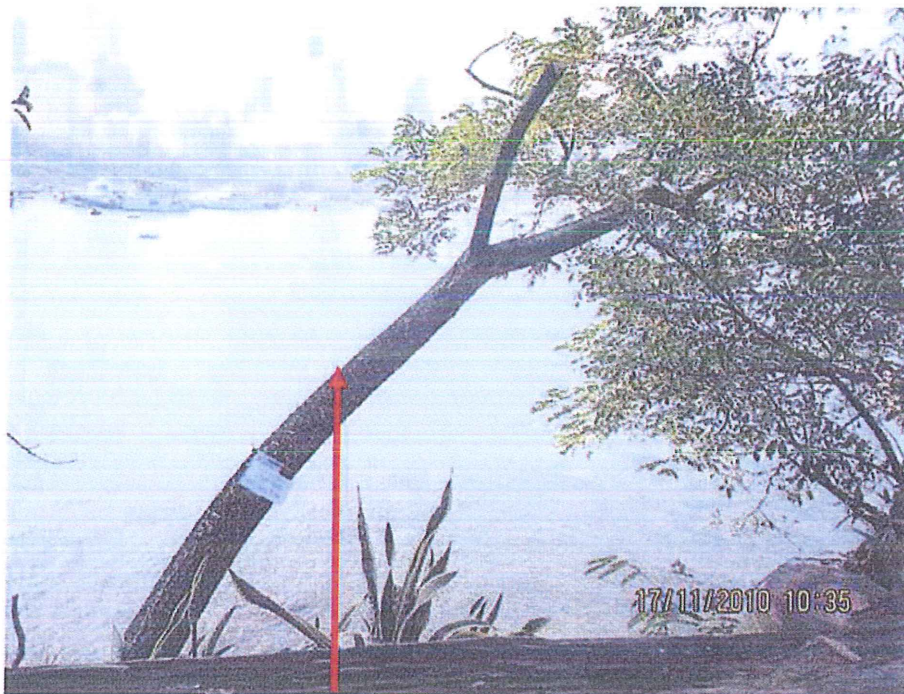
(l) Tree no. T1911 - Albizia lebbbeck 大葉合歡

Leaning severely within existing rock slope

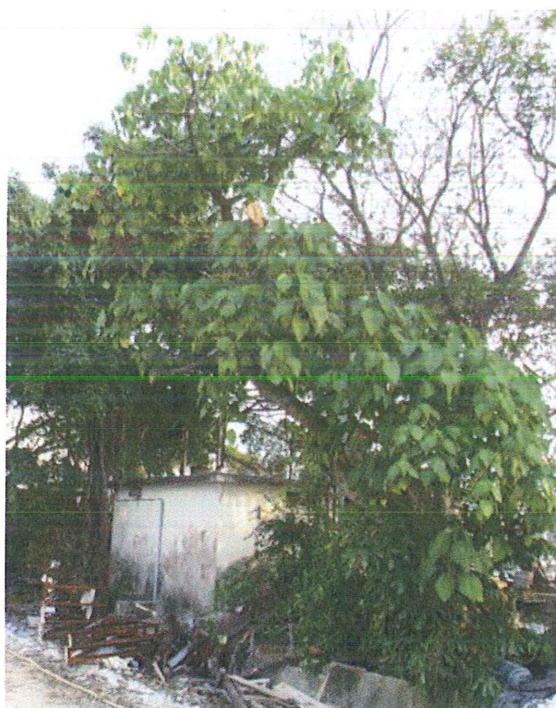
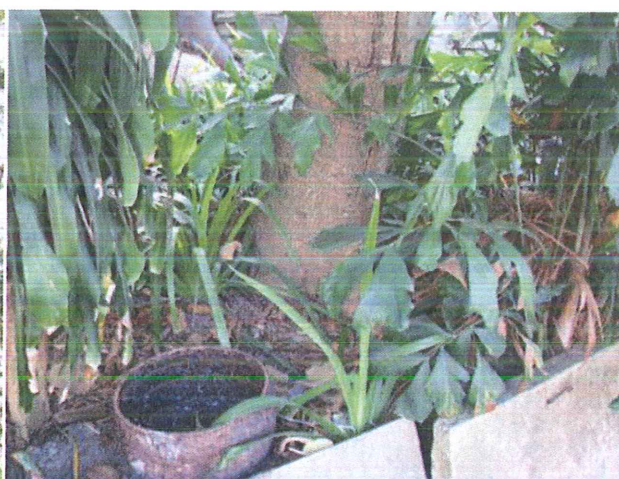
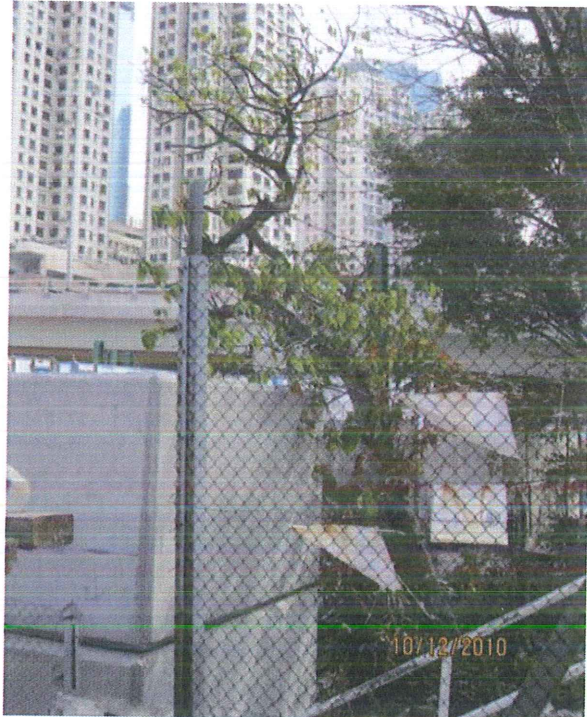
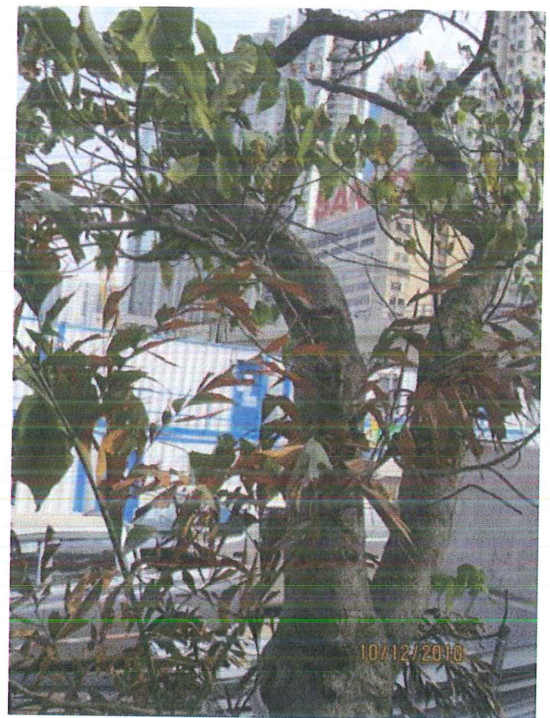
1. Location of the Incident: At Portion 22
2. Tree No.: T1905
3. Species of Trees: *Macaranga tanarius* 血桐
4. Size of Trees: Height 7m, Crown Spread 5m, DBH 330mm
5. Status: Transplant
6. Date and Time (incident occurred): 24/1/2011, 15:00
7. Nature and Brief Account of the Incident:
  - i. Termite attack
  - ii. Less than 20% of sound wood (xylem) remains.  
(Refer to appendix A)
8. Follow-up Actions being taken:
  - i. Removed the infected tree
  - ii. Used the registered pesticide to prevent further infection to other trees. (Refer to appendix B)
  - iii. Inspection the other trees to check whether the invasion of termites.
9. Relevant Background Information: recently photos for T1905

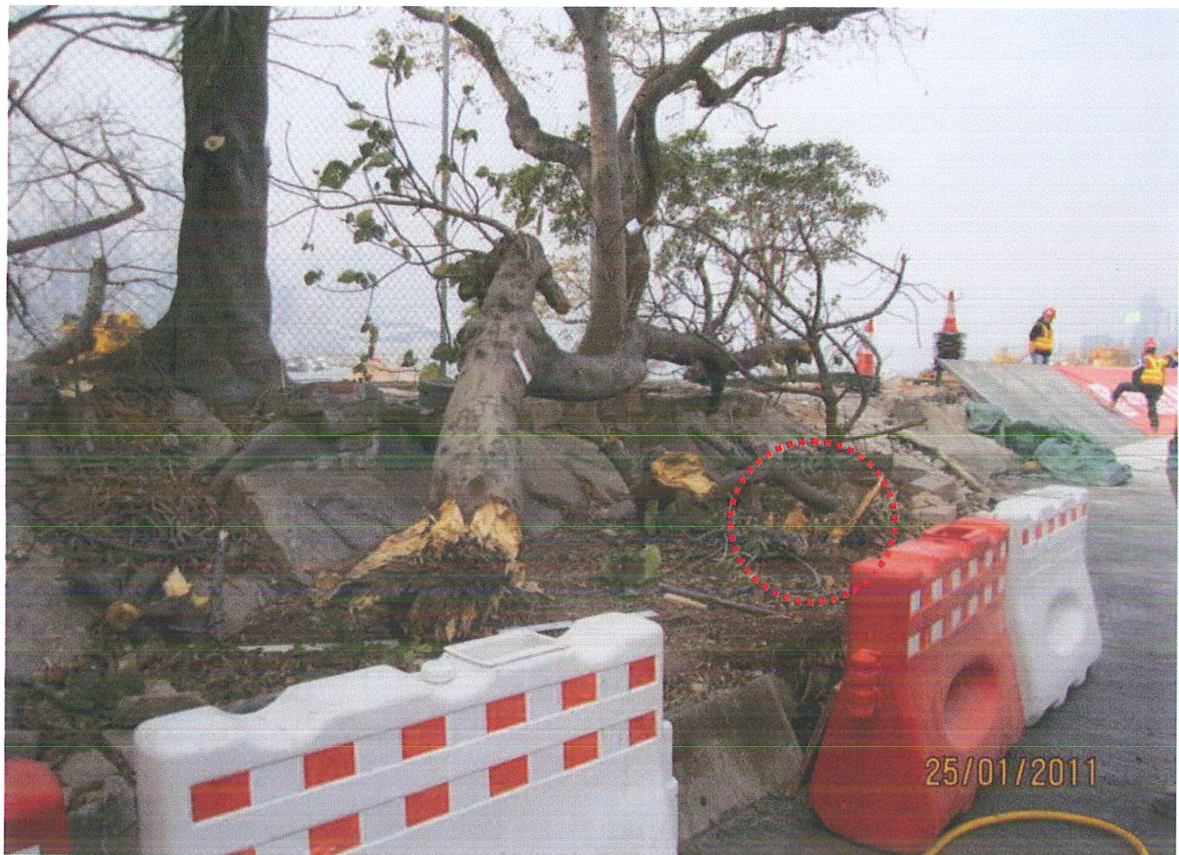
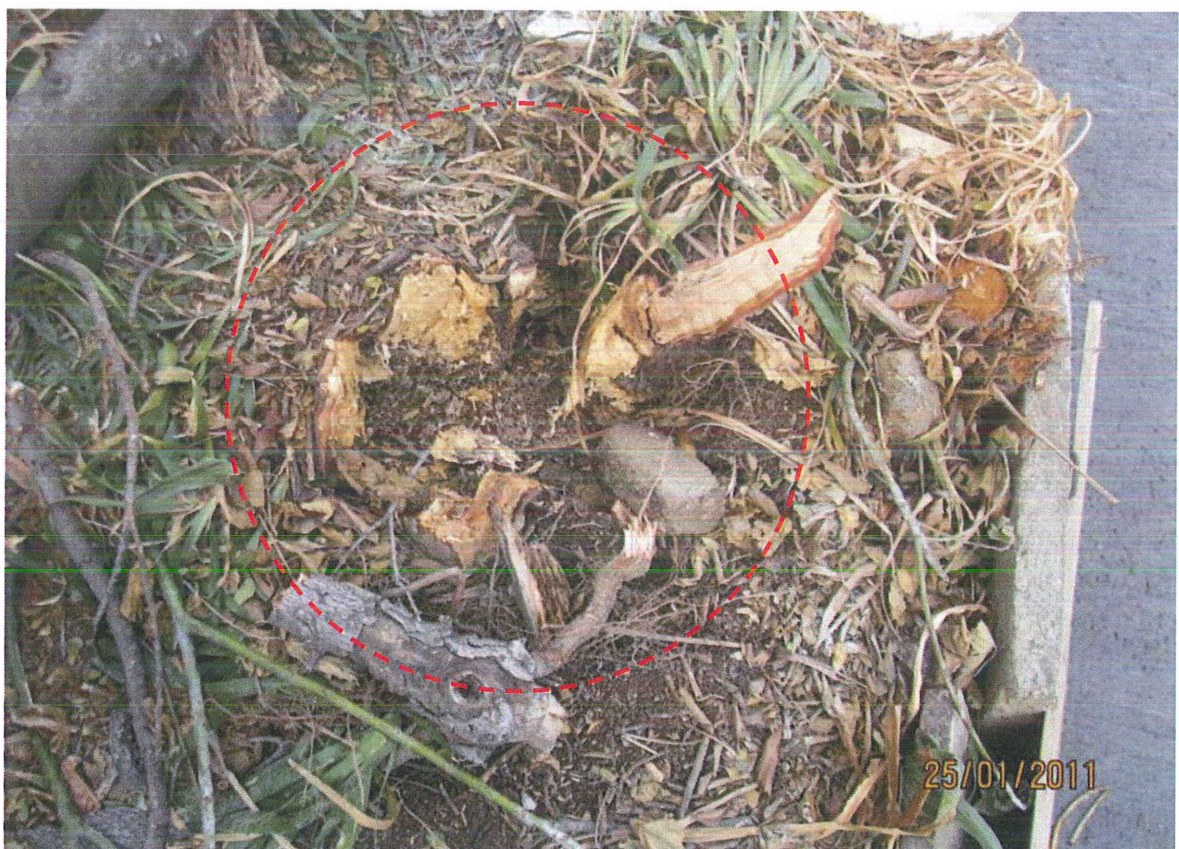
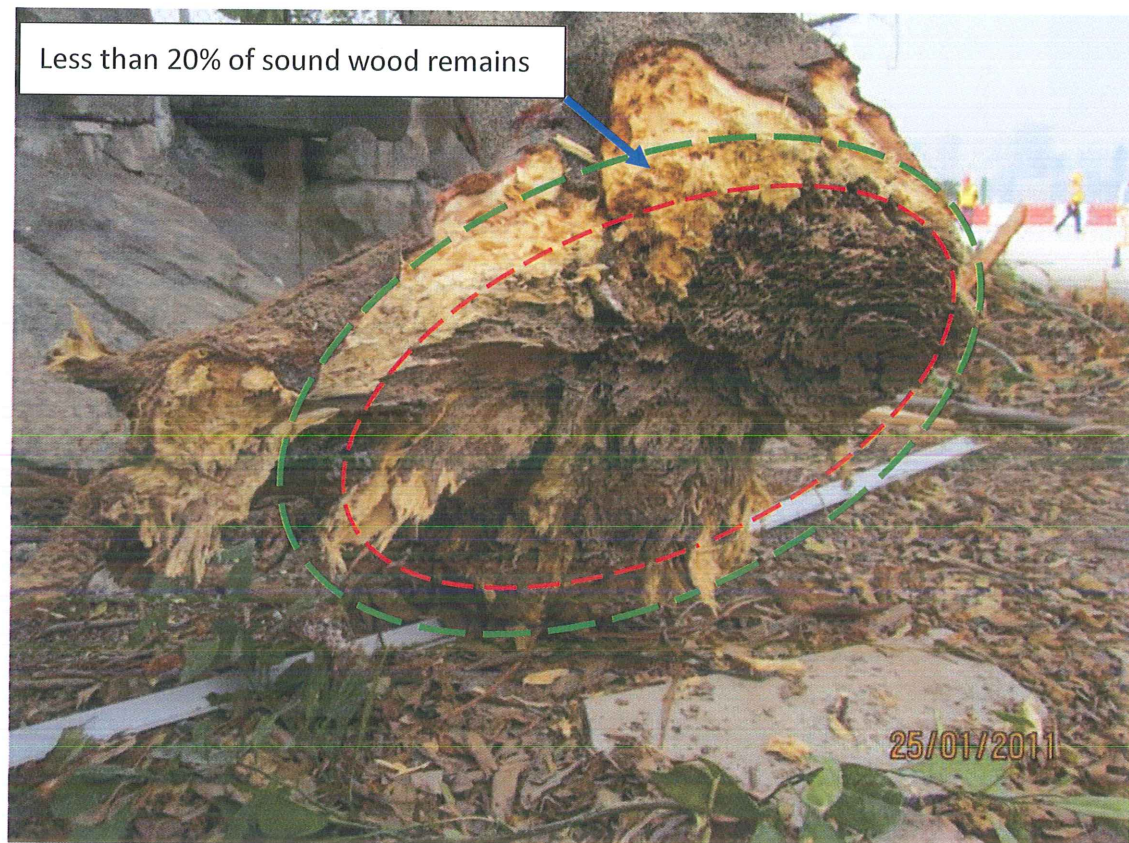
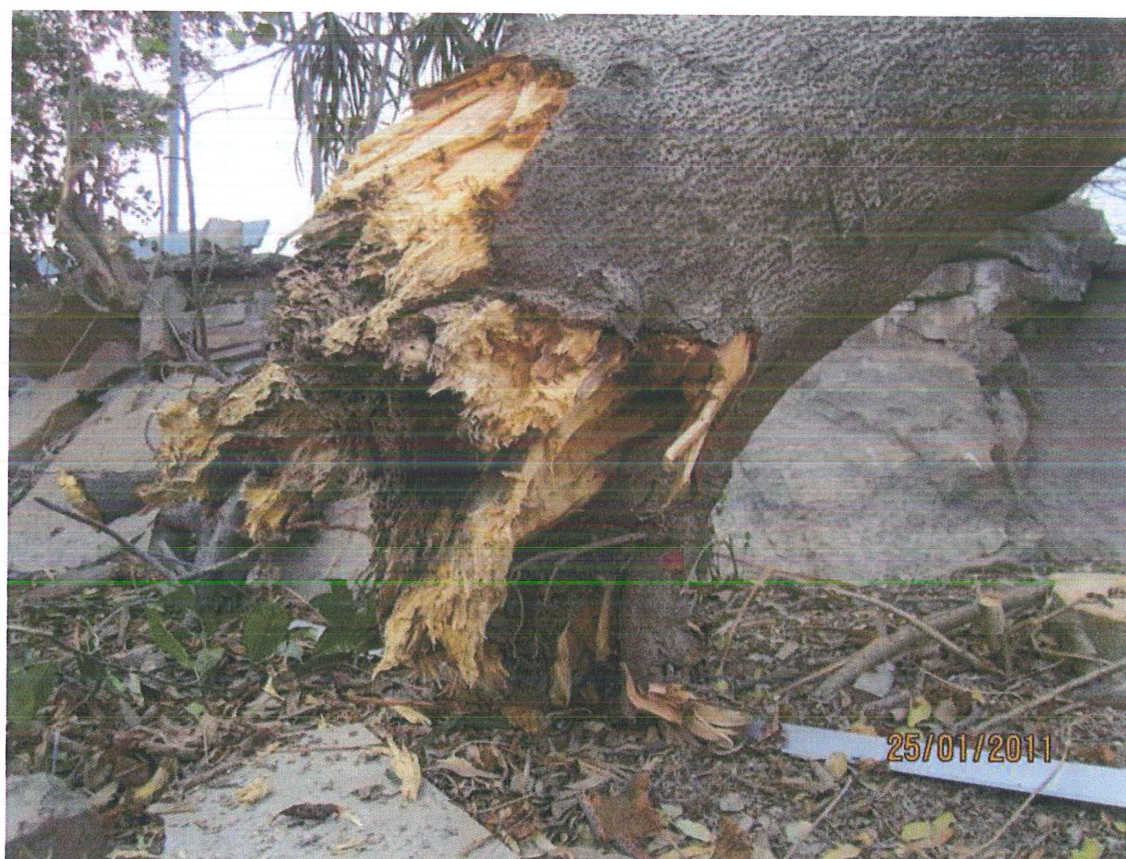
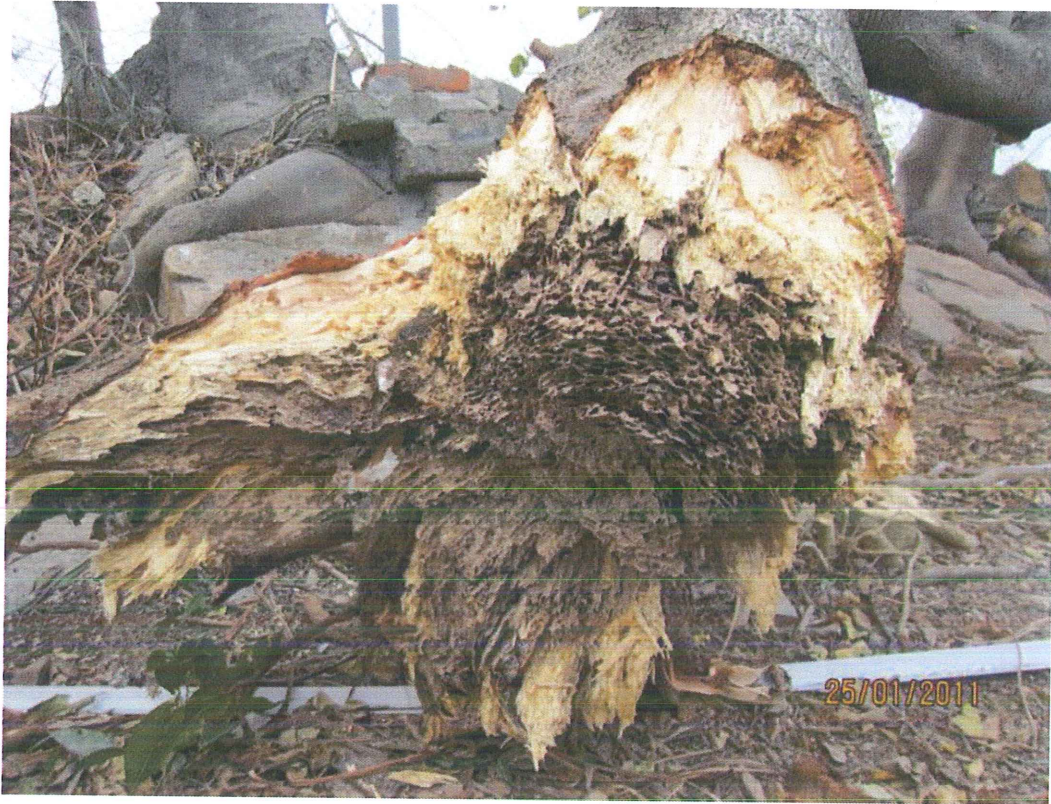
Tree No. T1905

Termite nest
